PROPERTY CONDITION ASSESSMENT

108 RUSH STREET
MOUNT HOLLY, NORTH CAROLINA

ECS PROJECT NO. 48:3582

OCTOBER 23, 2023

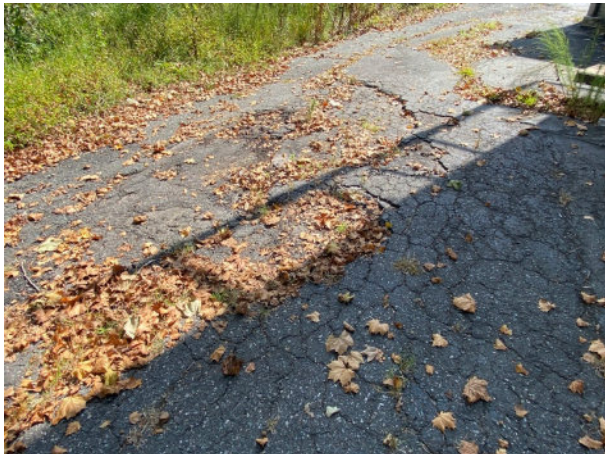
Asphalt-paved drive lanes are located on the southwest, south, east, and north sides of the site. The asphalt pavement was observed to be in generally fair/poor condition. We observed areas of block and alligator cracks in the drive lanes and parking spaces. The expected useful life of asphalt pavement is 20 years. We recommend repairing these areas of asphalt pavement and providing an allowance to overlay the remainder of the asphalt pavement.

Deteriorated asphalt paving at east side

Cost Recommendation	EUL	EFF AGE	RUL	Year	Cost
ROOT REPAIR & REPLACE EXISTING ASPHALT	-	-	-	1	\$125,025
MILL, OVERLAY AND RESTRIPE EXISTING ASPHALT	-	-	-	1	\$58,300
REMOVE AND REPLACE UNREINFORCED SLAB	-	-	-	1	\$11,250
Total					\$194,575

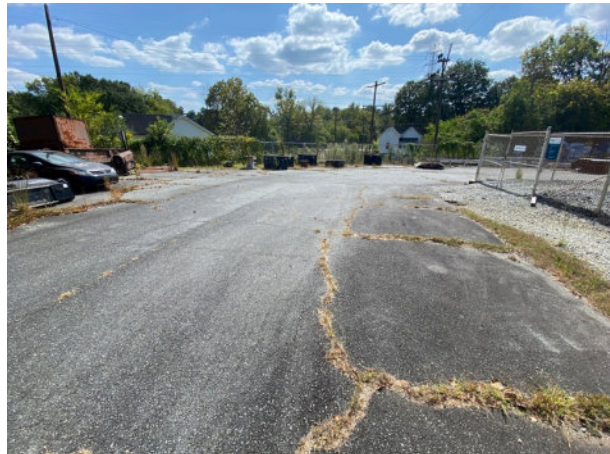
Deteriorated asphalt paving at east side

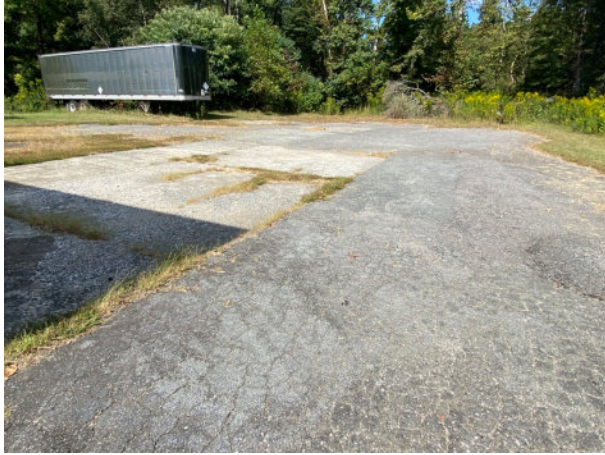
Concrete pavement is located on the southwest, south, and north sides of the site. The pavement was observed to be in generally good/fair condition: areas of cracked and spalled concrete pavement were observed. ECS recommends an allowance for replacement of these areas of concrete pavement.

Deteriorated asphalt & concrete paving at north end

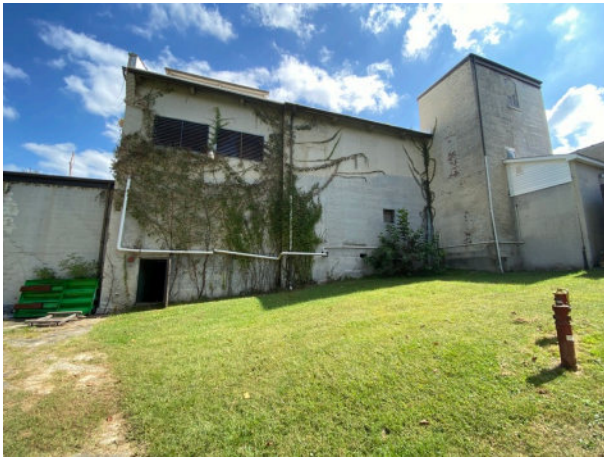
The landscaping consists generally of mature trees and grassed areas around the site. The landscaping was observed to be in generally good condition. However, ivy was observed growing on the walls at the west side of the building, and a tree was observed to be growing inside a masonry pier on the east side of the building. ECS recommends the ivy and tree be removed as part of routine maintenance. (The masonry repairs to the pier are discussed in section 3.3.3.)

West elevation (note ivy on walls)

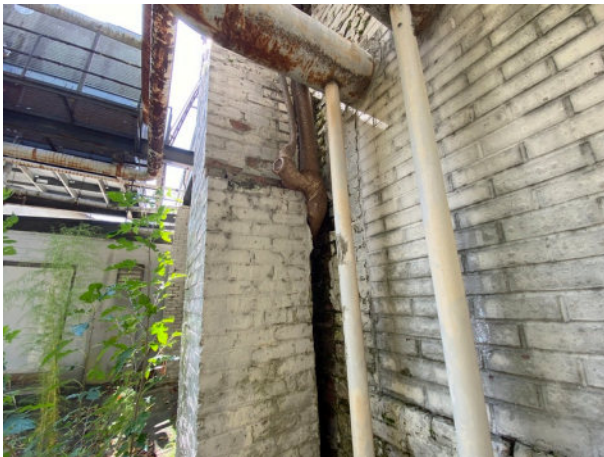
Damaged masonry pier at east side (note tree in pier)

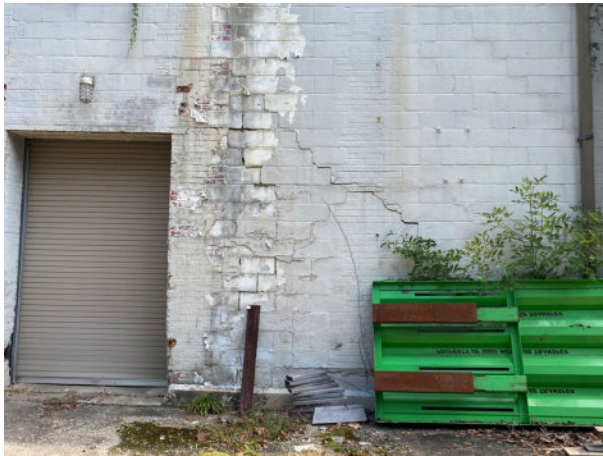
The foundation type was unknown. The foundation system appeared to provide adequate structural support to the building, with the exception of an area on the west side of the north wing, where a grade beam appears to be sagging and has apparently caused severe cracking in the masonry walls. ECS recommends further assessment and repairs as required.

Sagging grade beam & cracked masonry at west side

Cost Recommendation	EUL	EFF AGE	RUL	Year	Cost
FURTHER ASSESSMENT	-	-	-	Immediate	\$10,000
Total					\$10,000

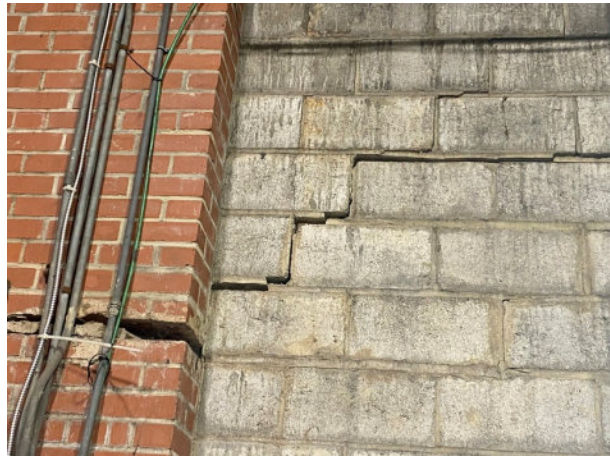
Cracked masonry at west side (interior view)

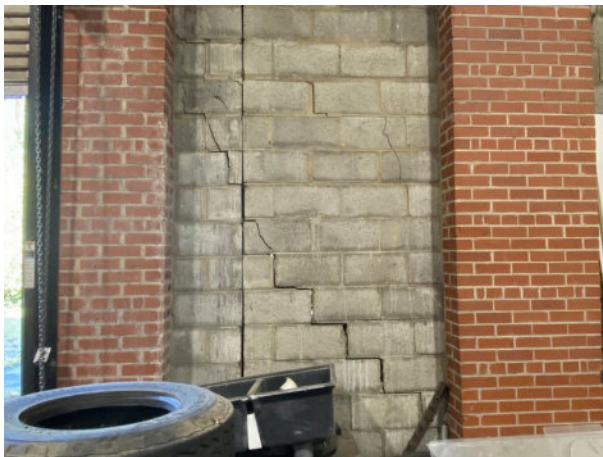
Cracked masonry at west side (interior view)

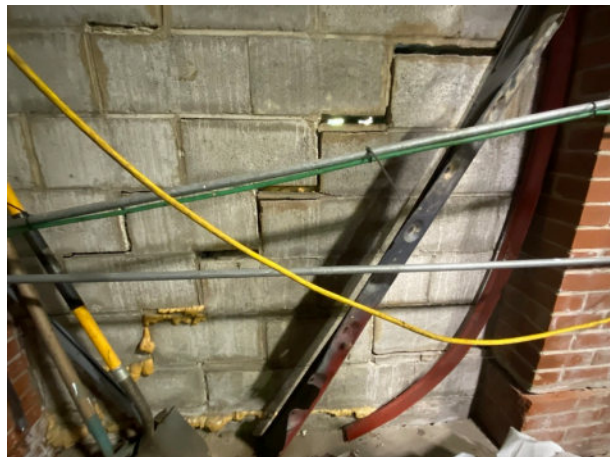
Cracked masonry at west side (interior view)

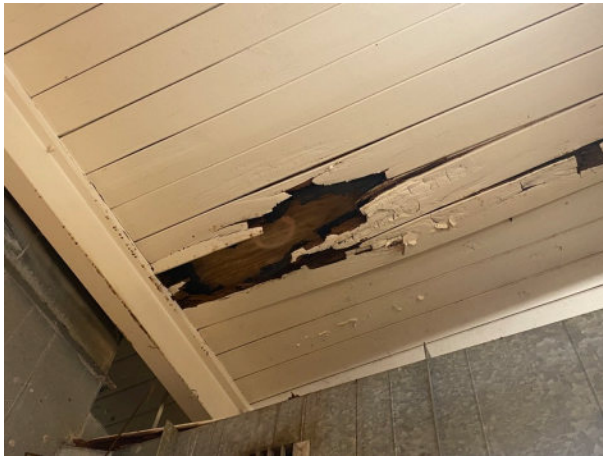
Deteriorated wood roof decking

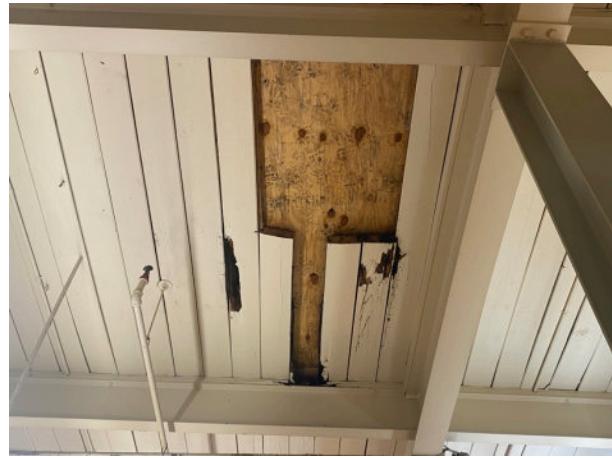
Poorly-supported plywood at gap in roof deck

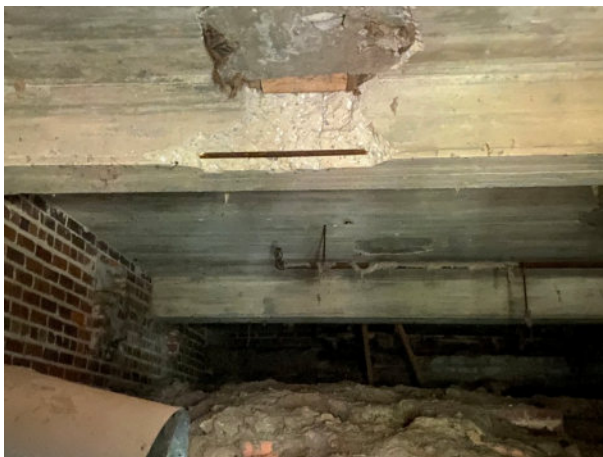
An area of spalled concrete and exposed reinforcing steel was observed on a beam supporting the north wing floor. ECS recommends the concrete beam be repaired.

Damaged concrete beam in crawlspace

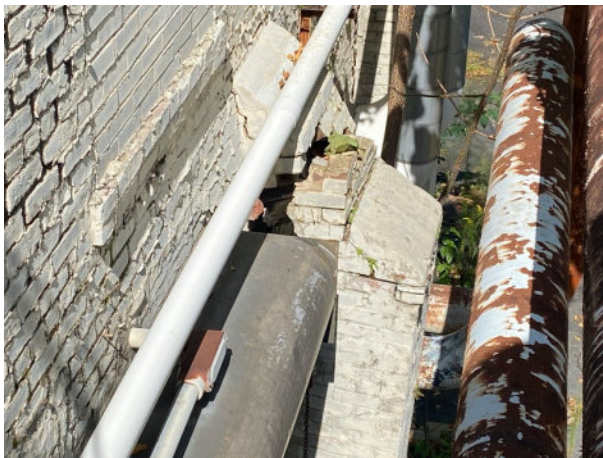
Damaged masonry pier at east side

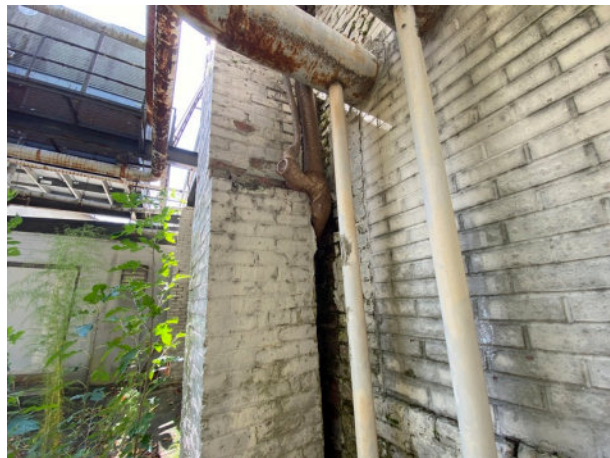
Damaged masonry pier at east side (note tree in pier)

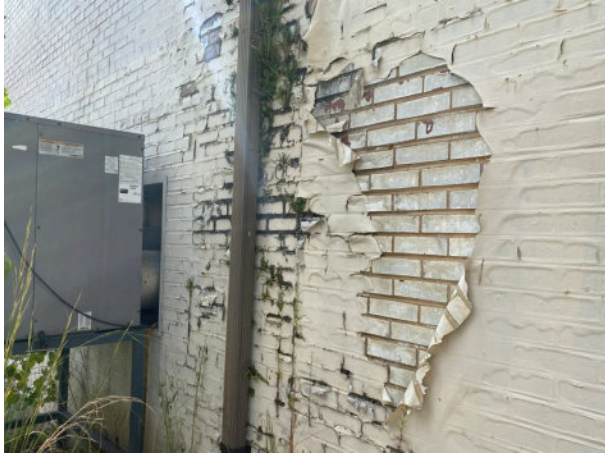
Failed paint on masonry

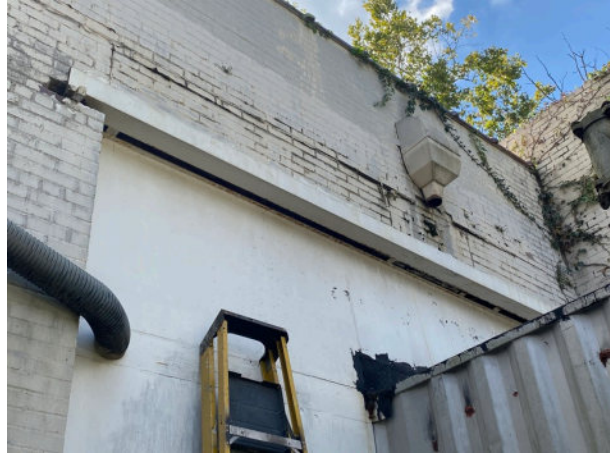
Cracked masonry at west side

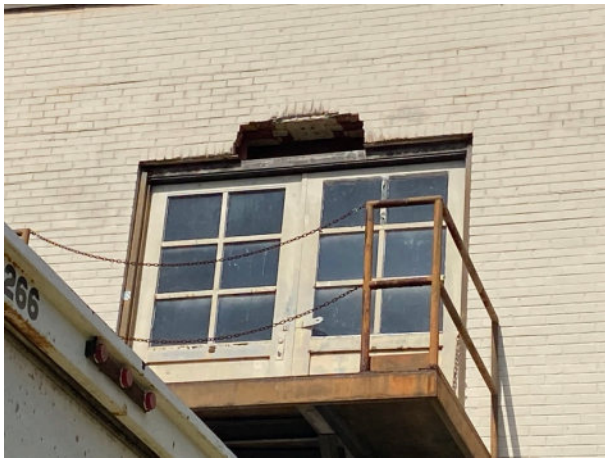
Damaged masonry at door head

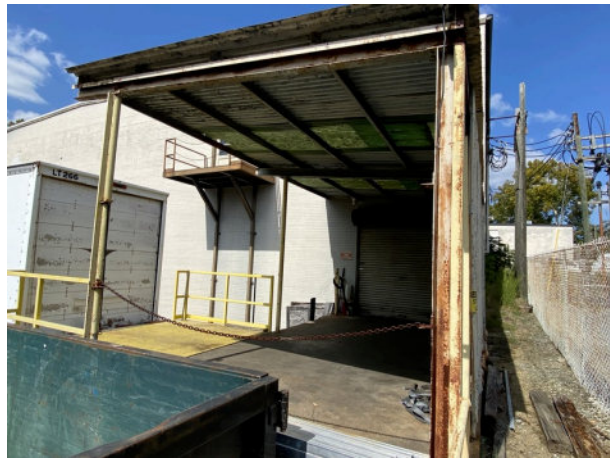
Corrosion at loading dock canopy framing

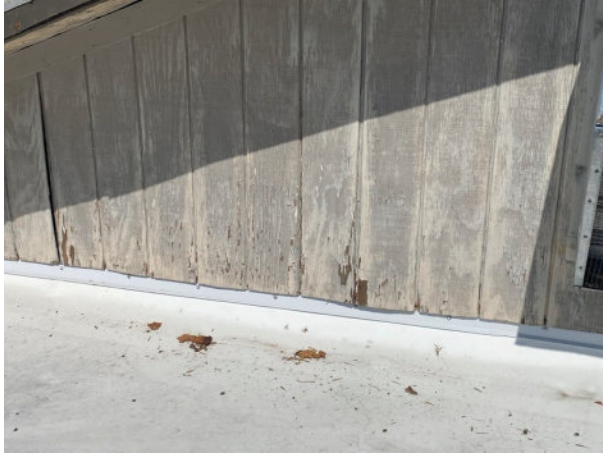
Failed paint on penthouse

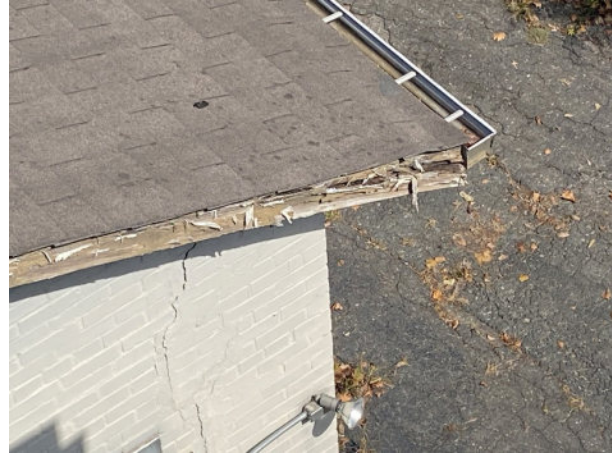
Damaged wood fascia at east side

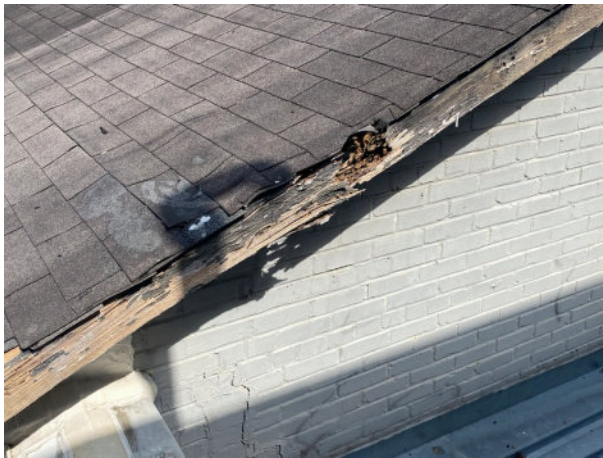
Damaged wood fascia at east side

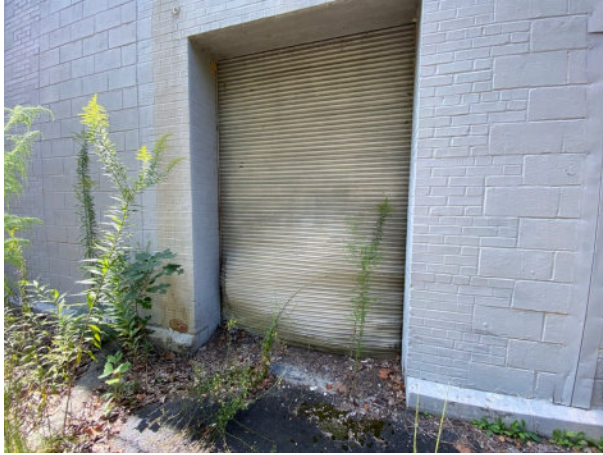
Damaged overhead door

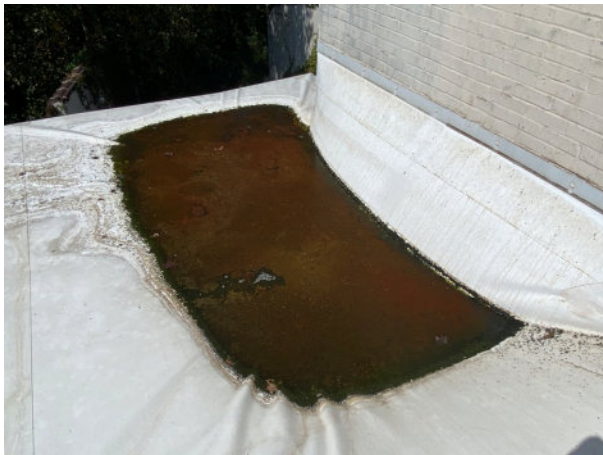
Ponding near elevator penthouse

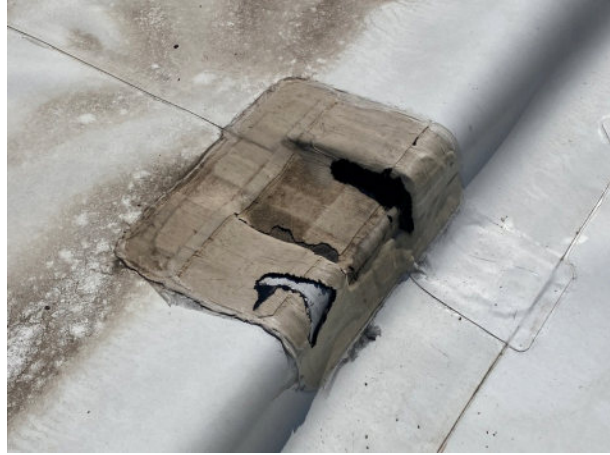
Deteriorated patch at main roof

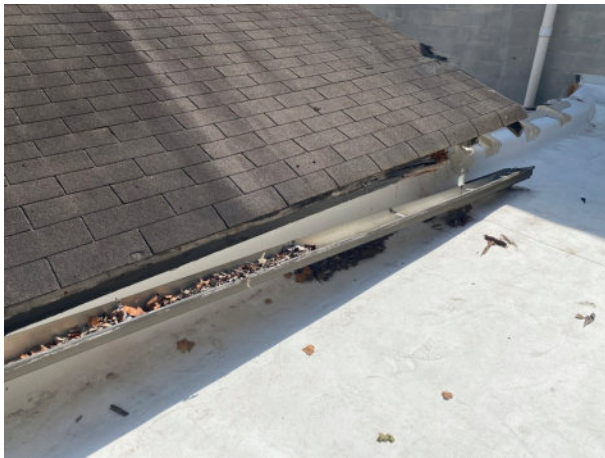
Damaged gutter at east side

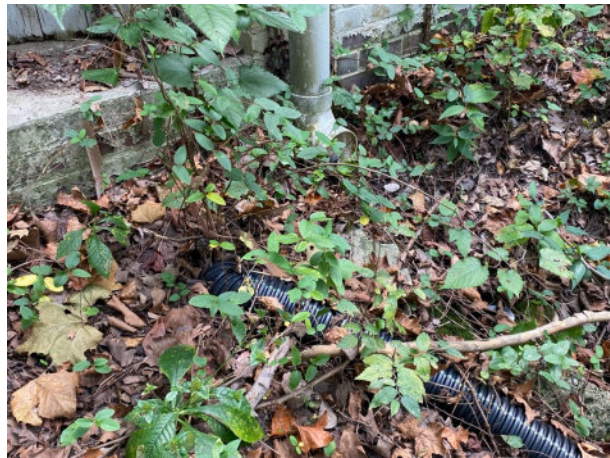
Detached drain line at downspout (west side)

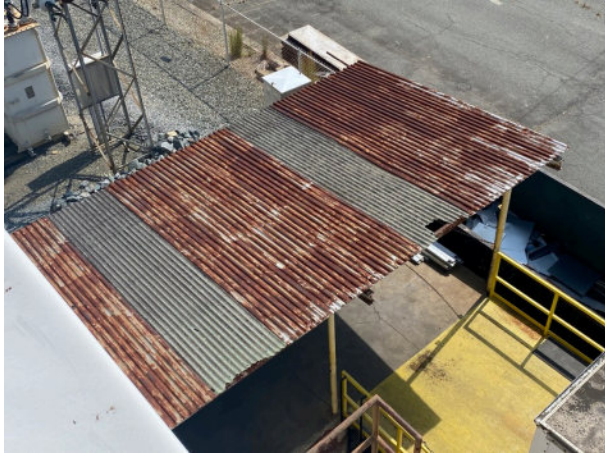
Corroded metal roofing at loading area

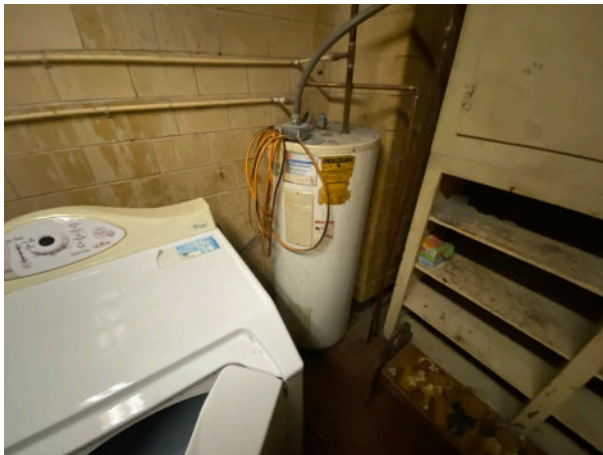
Domestic hot water to the building is provided by electric water heater located _____. The electric water heater was manufactured by Rheem in 1995. The expected useful life of an electric water heater is approximately 15 years with proper maintenance. ECS recommends the electric water heater be replaced as part of general maintenance.

Water heater

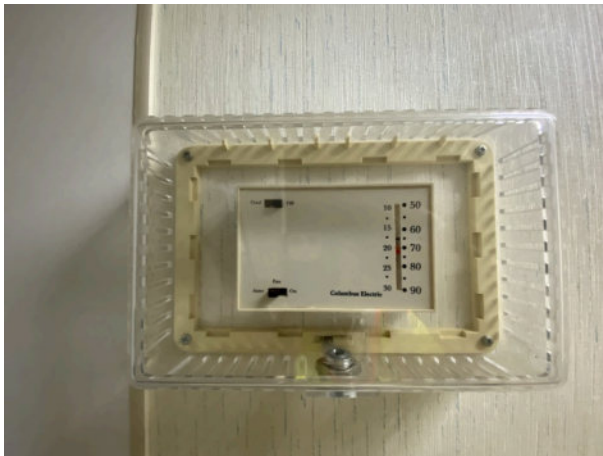
The thermostats are analog. The thermostats were observed to be in generally good/fair condition. ECS recommends the thermostats be replaced with digital units as part of general maintenance.

Typical thermostat

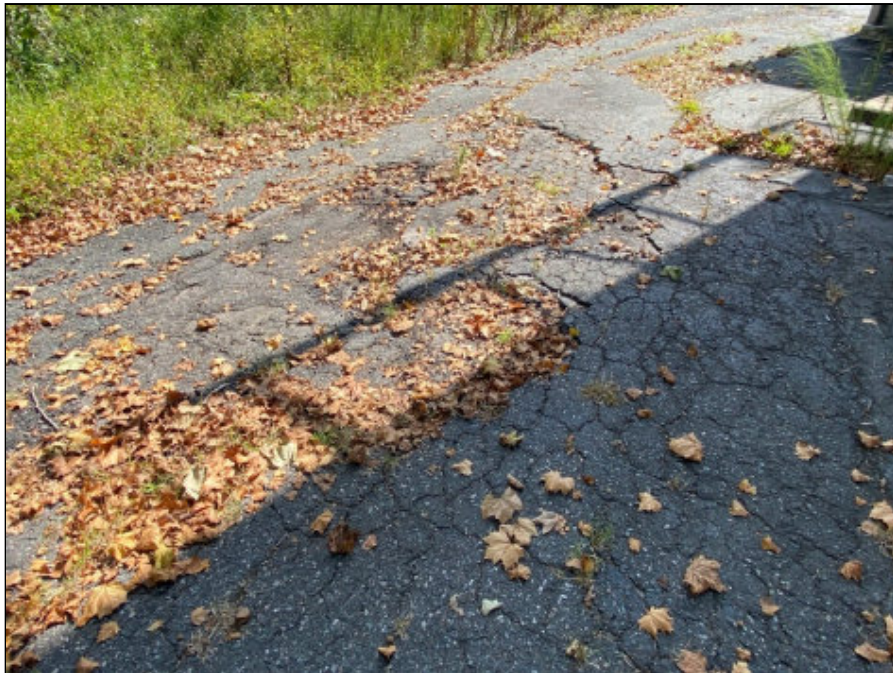
22 - Deteriorated asphalt paving at east side

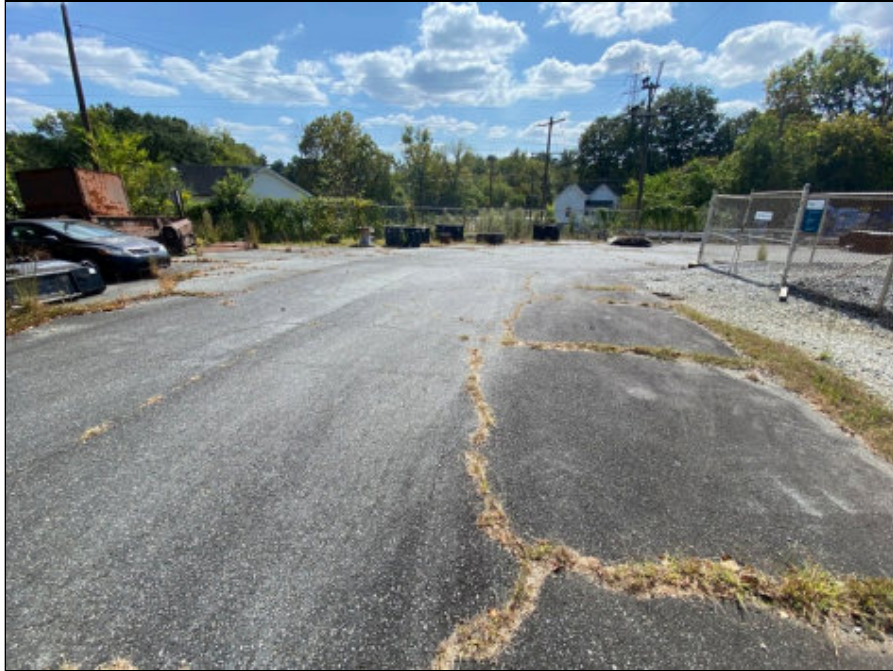
23 - Deteriorated asphalt paving at east side

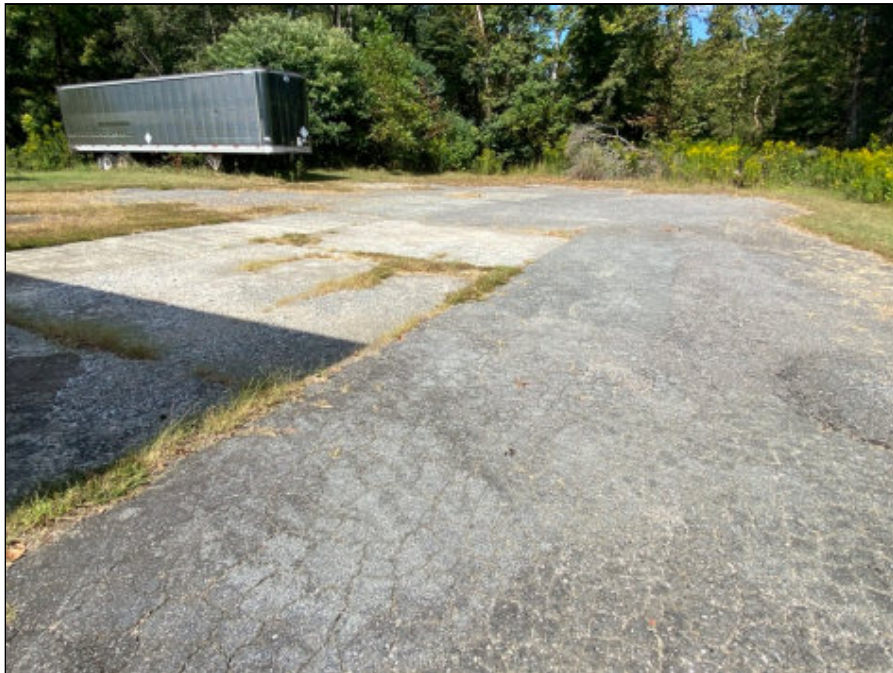
24 - Deteriorated asphalt & concrete paving at north end

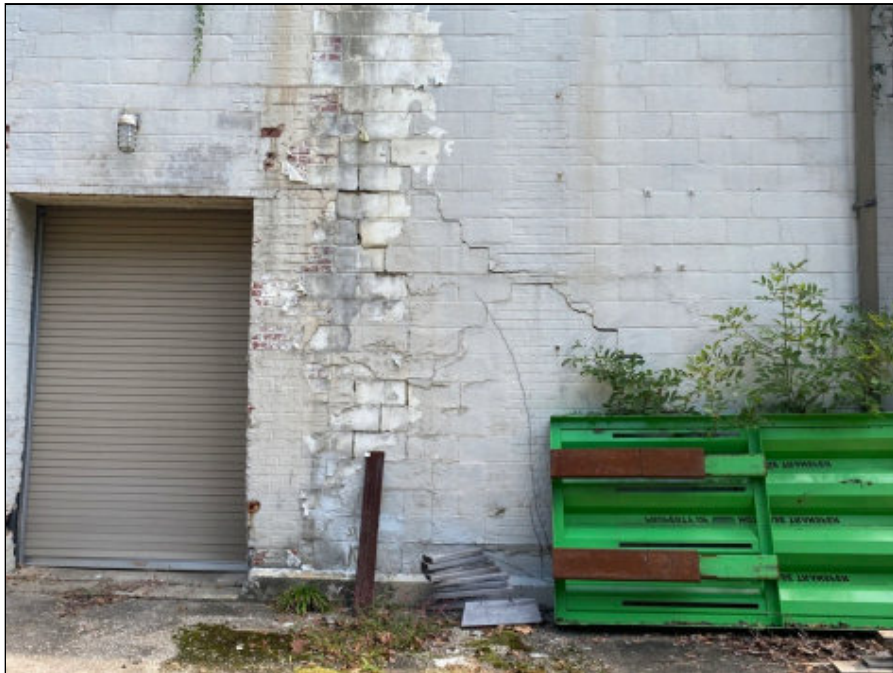
30 - Sagging grade beam & cracked masonry at west side

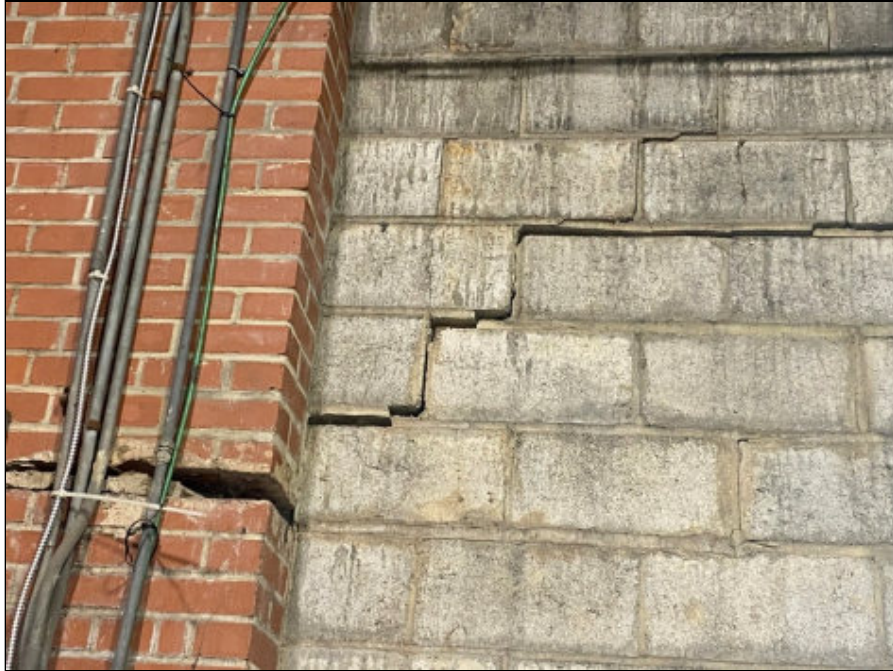
31 - Cracked masonry at west side (interior view)

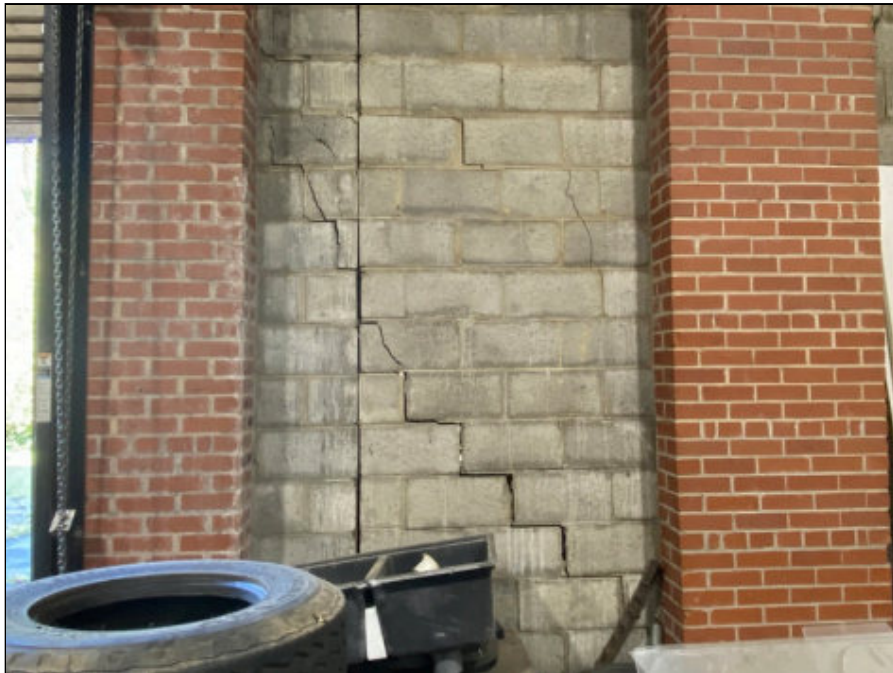
32 - Cracked masonry at west side (interior view)

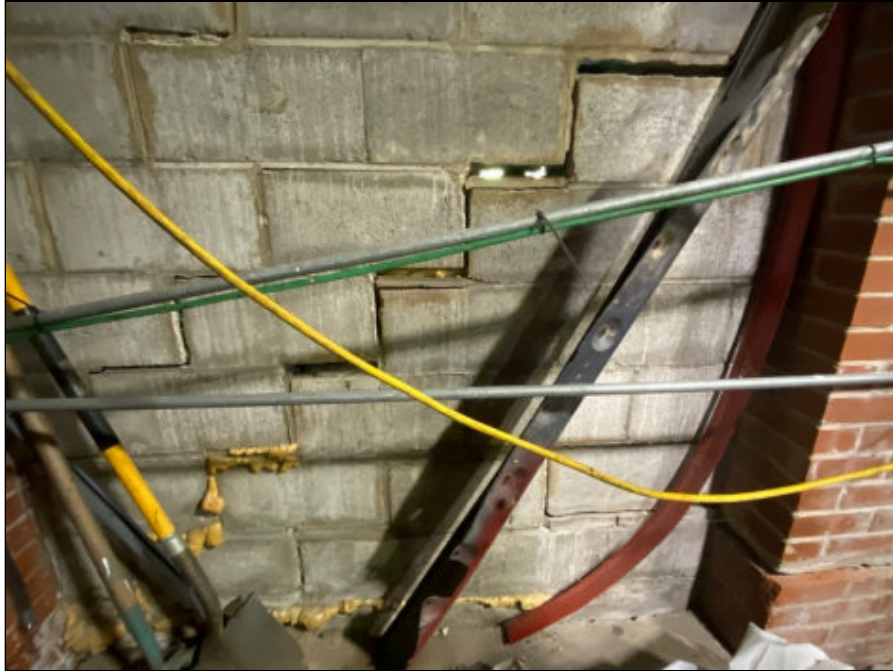
33 - Cracked masonry at west side (interior view)

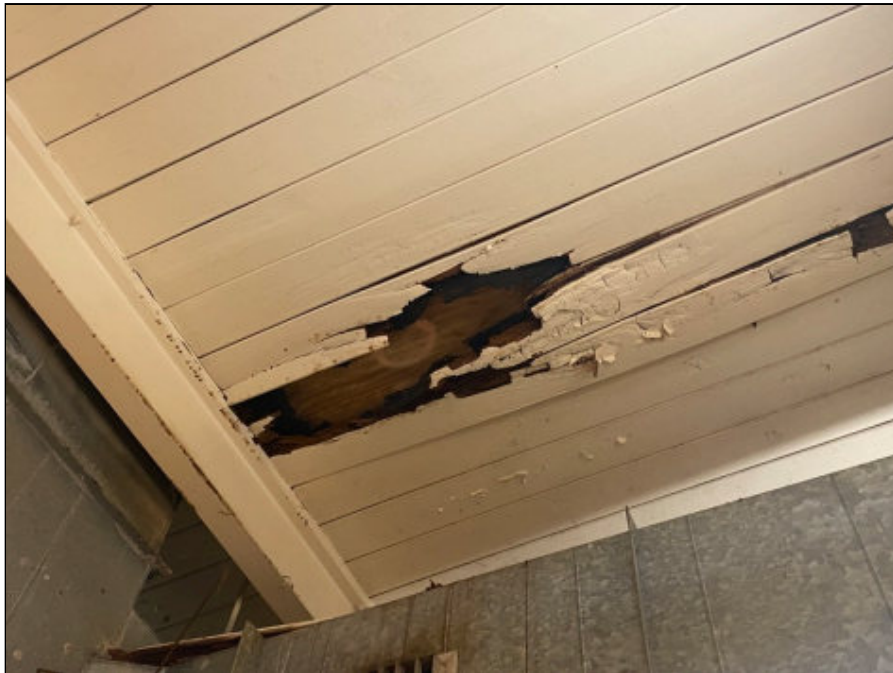
36 - Deteriorated wood roof decking

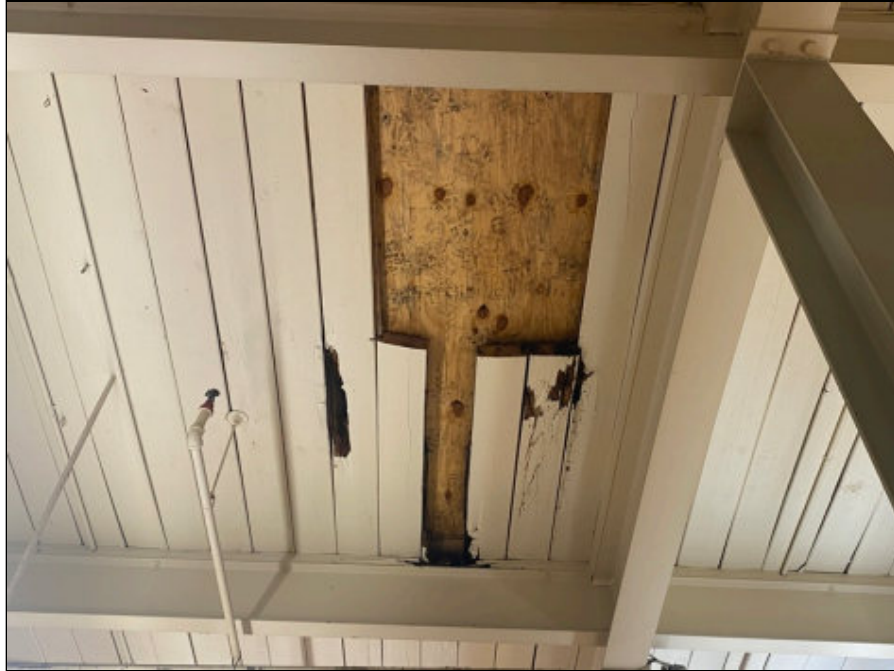
37 - Poorly-supported plywood at gap in roof deck

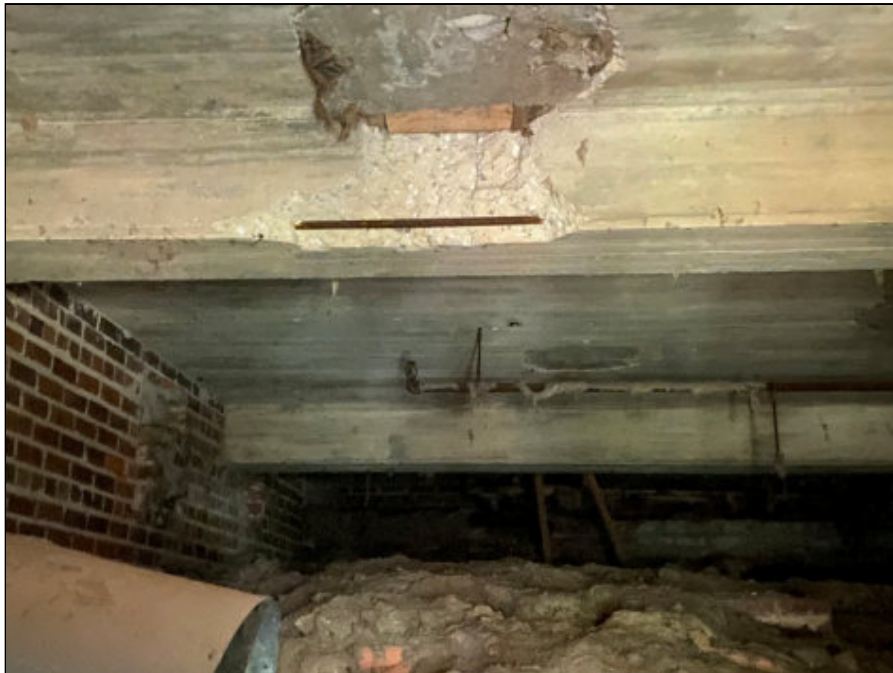
40 - Damaged concrete beam in crawlspace

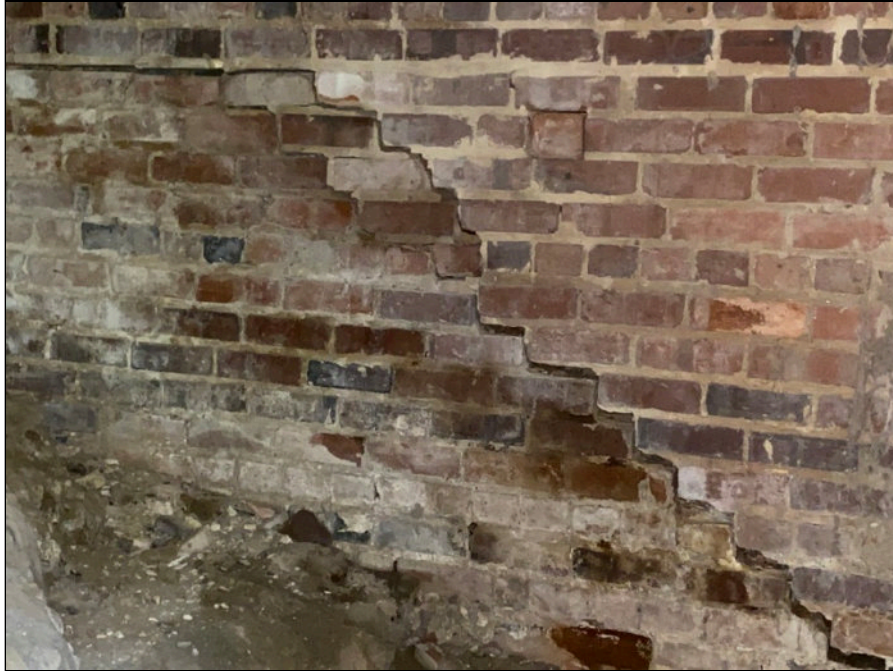
41 - Cracked masonry in crawlspace

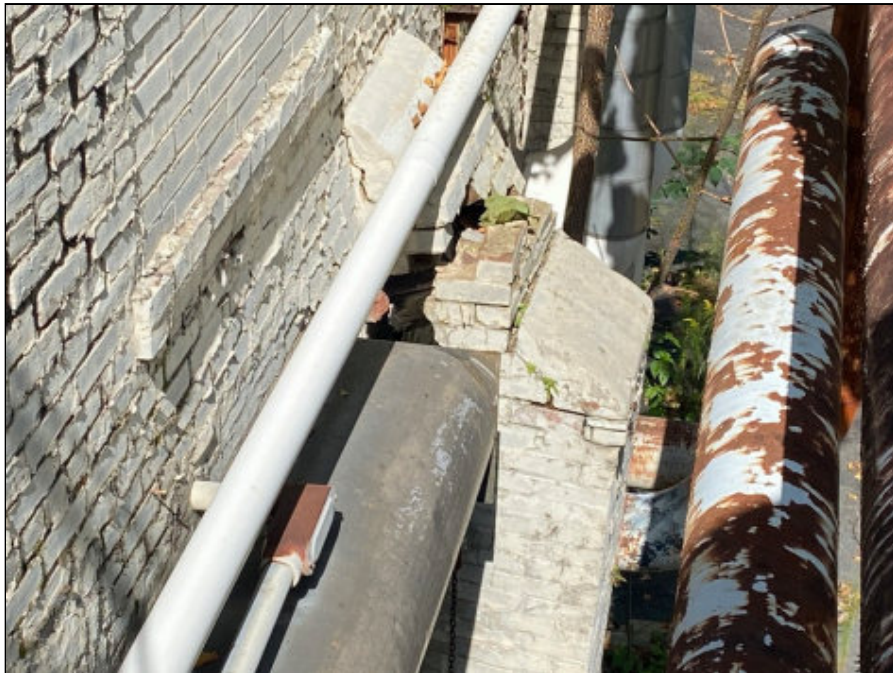
42 - Damaged masonry pier at east side

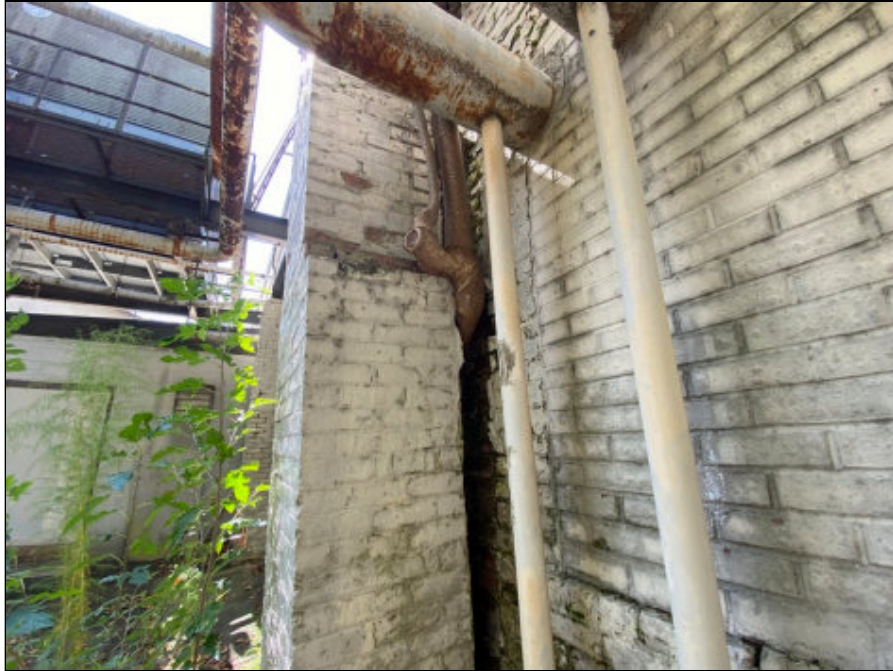
43 - Damaged masonry pier at east side (note tree in pier)

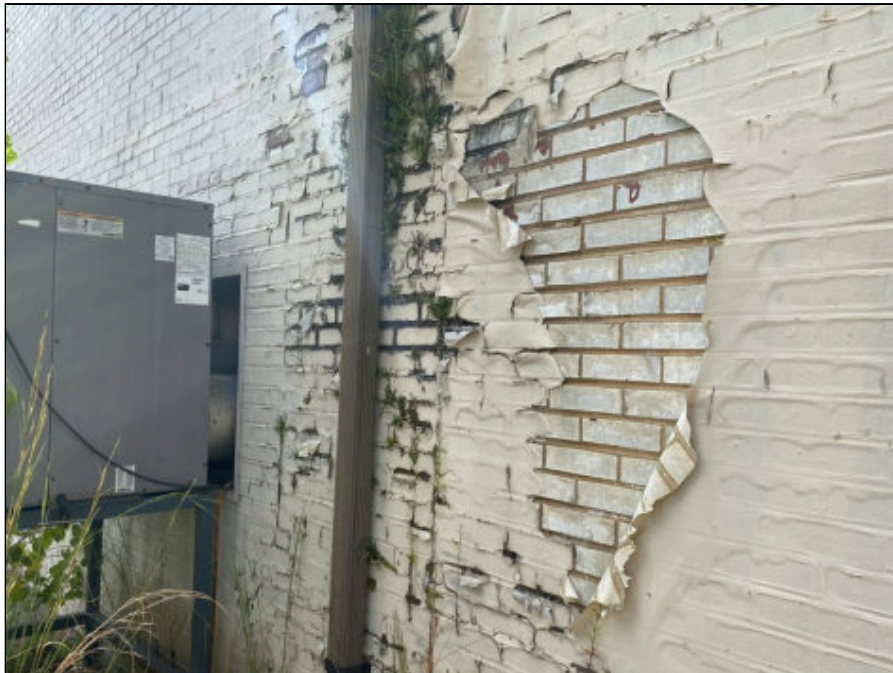
44 - Failed paint on masonry

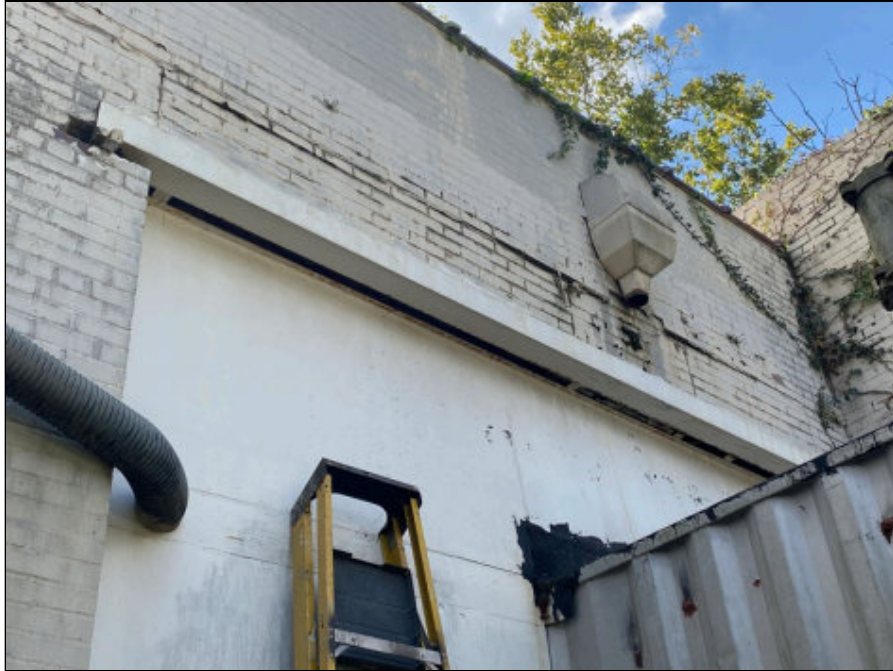
45 - Cracked masonry at west side

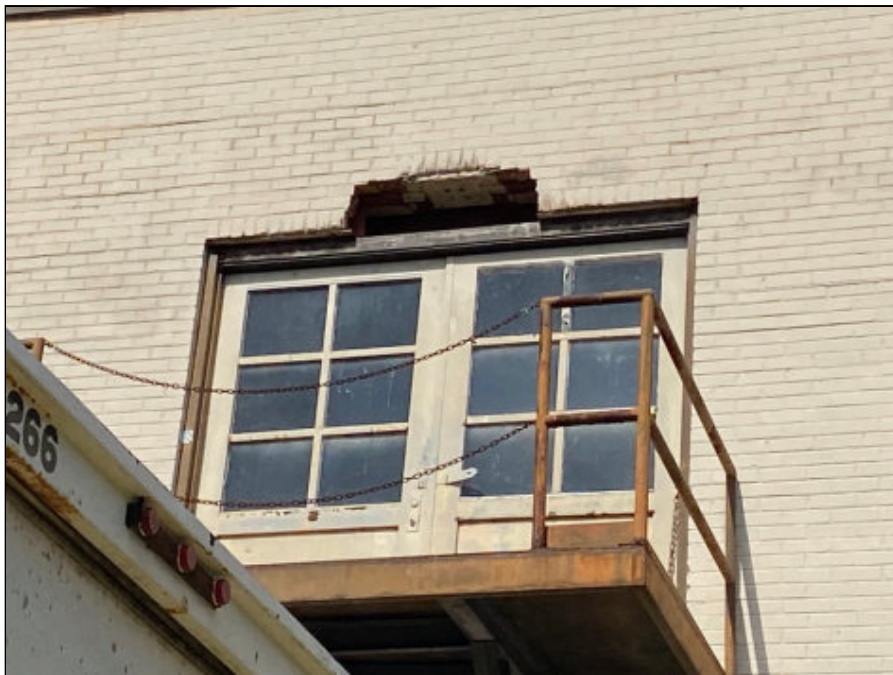
48 - Damaged masonry at door head

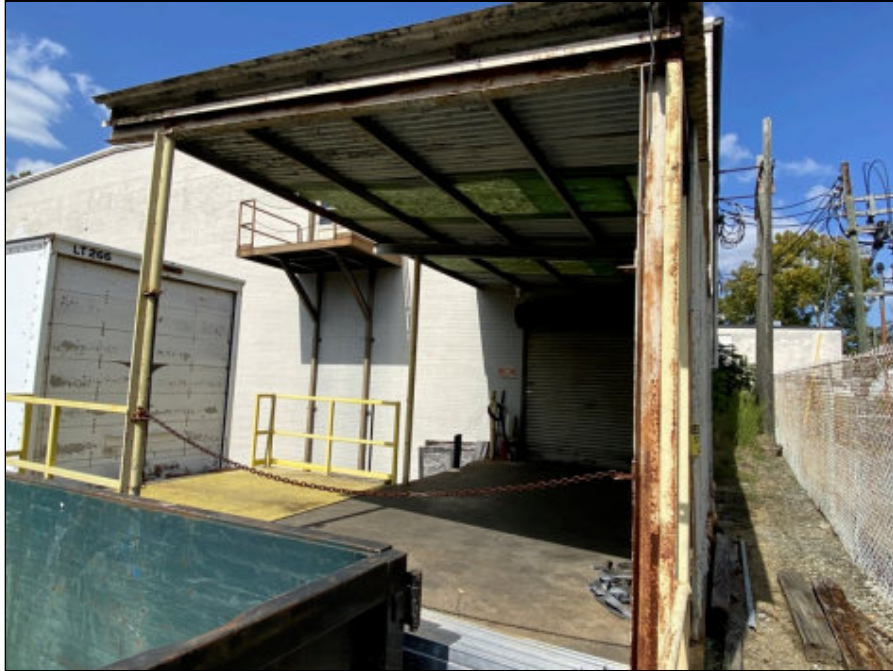
49 - Corrosion at loading dock canopy framing

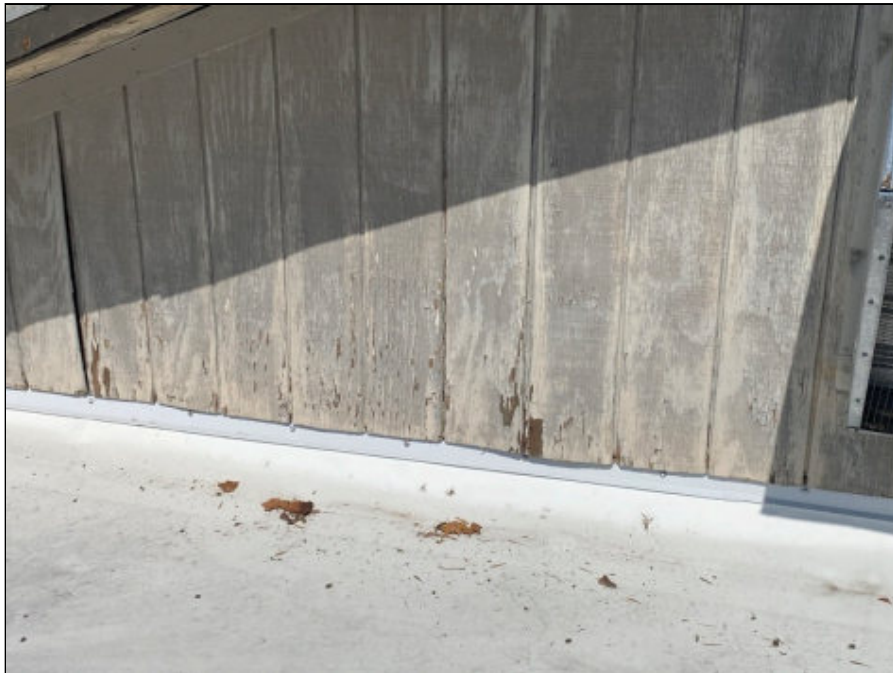
50 - Failed paint on penthouse

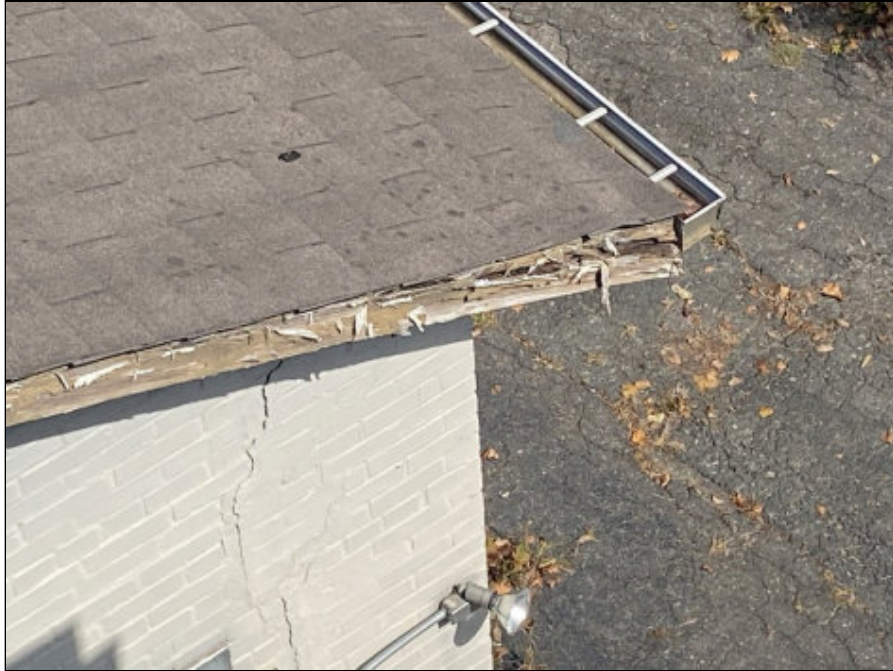
51 - Damaged wood fascia at east side

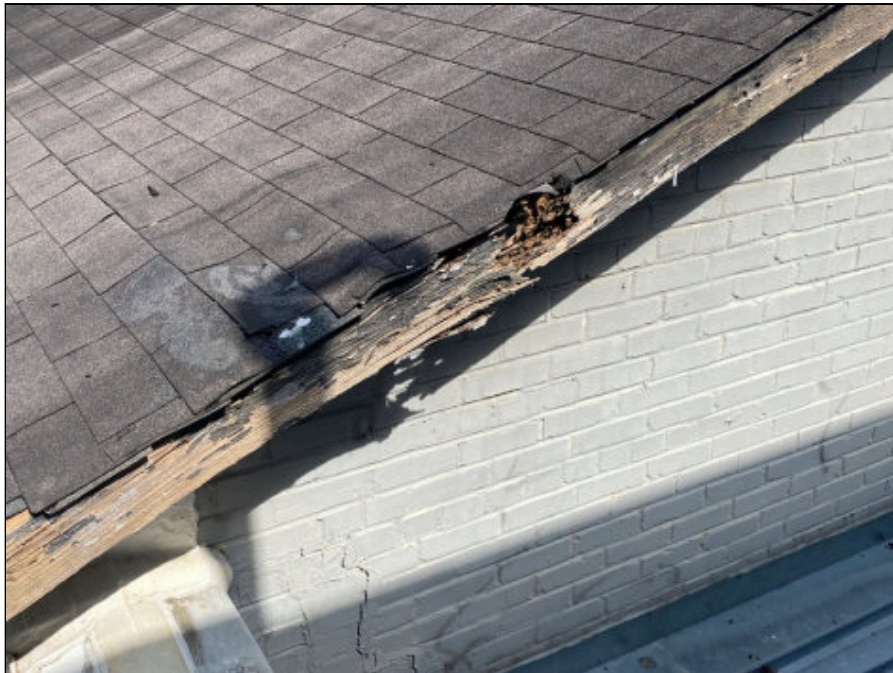
52 - Damaged wood fascia at east side

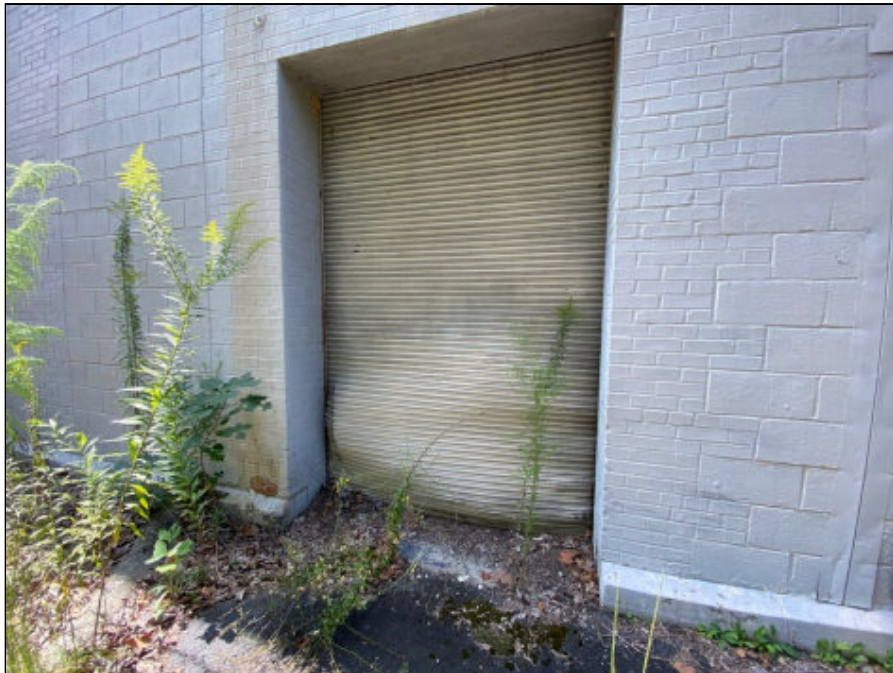
56 - Damaged overhead door

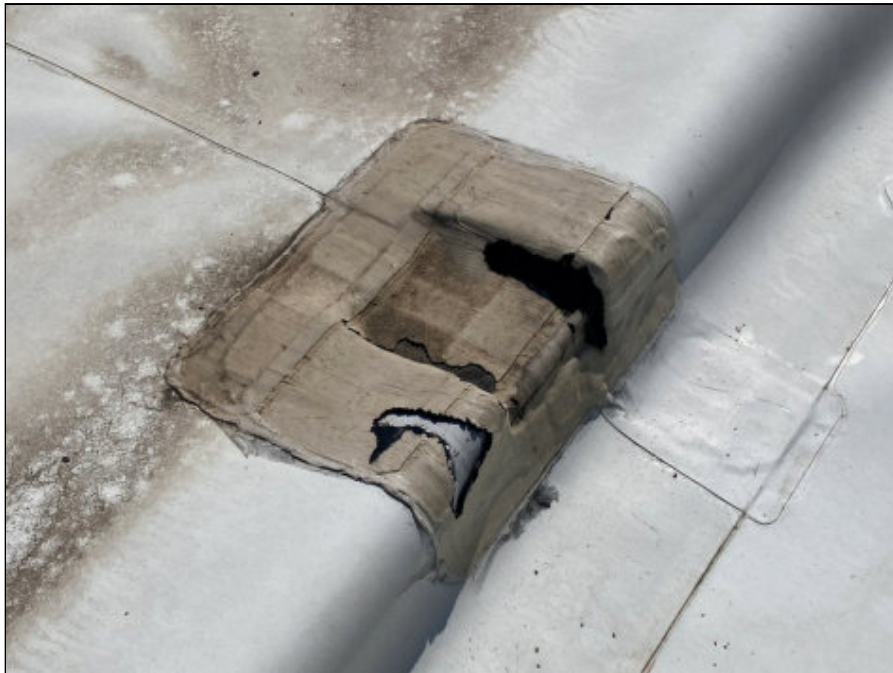
74 - Deteriorated patch at main roof

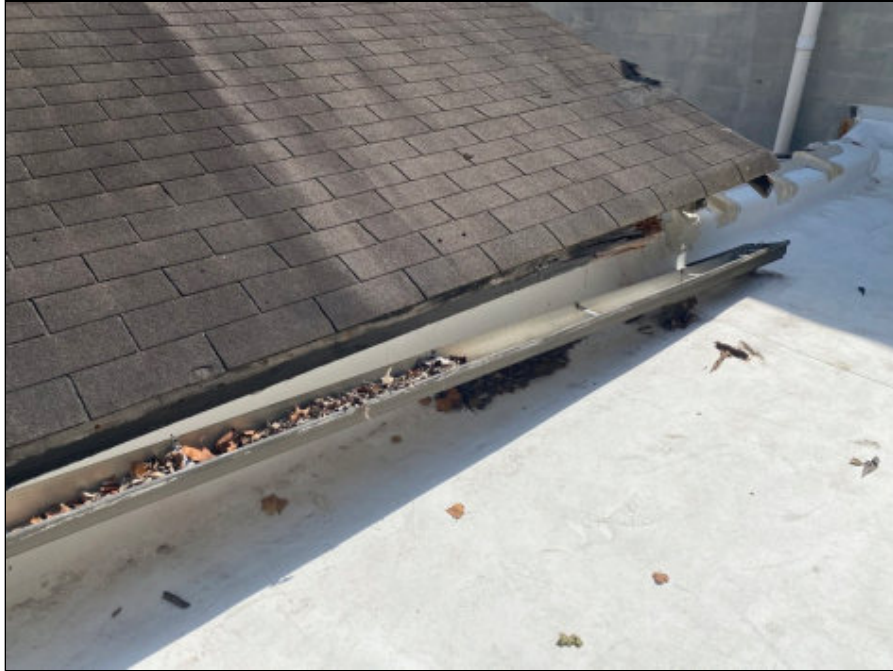
77 - Damaged gutter at east side
