PROPERTY CONDITION ASSESSMENT

108 RUSH STREET
MOUNT HOLLY, NORTH CAROLINA

ECS PROJECT NO. 48:3582

OCTOBER 23, 2023

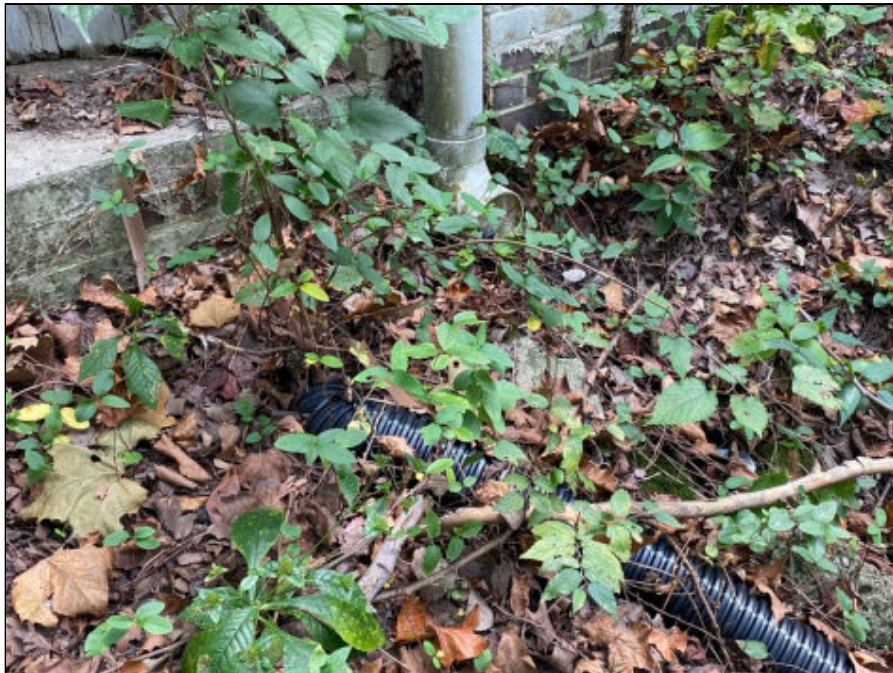
78 - Detached drain line at downspout (west side)

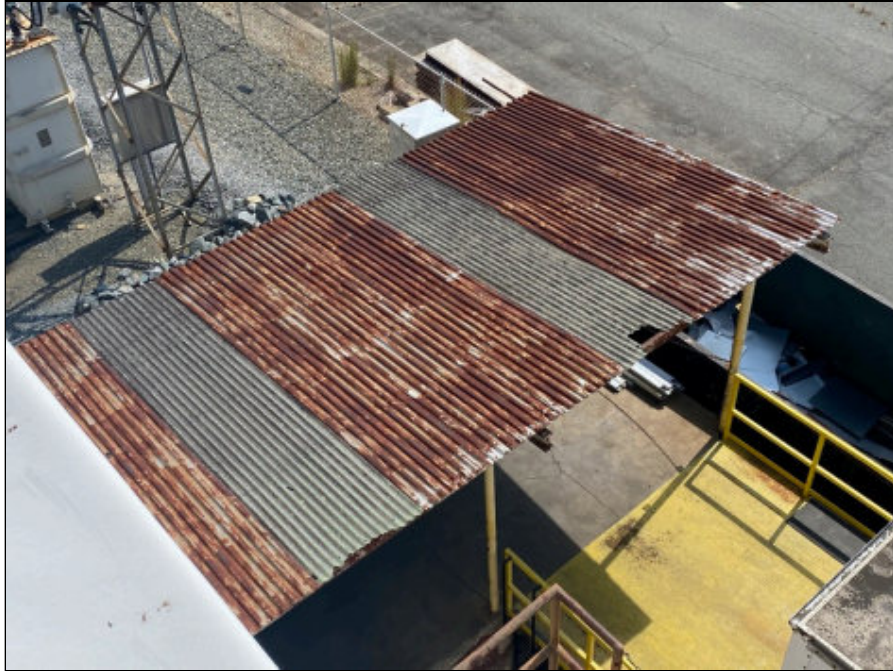
79 - Corroded metal roofing at loading area

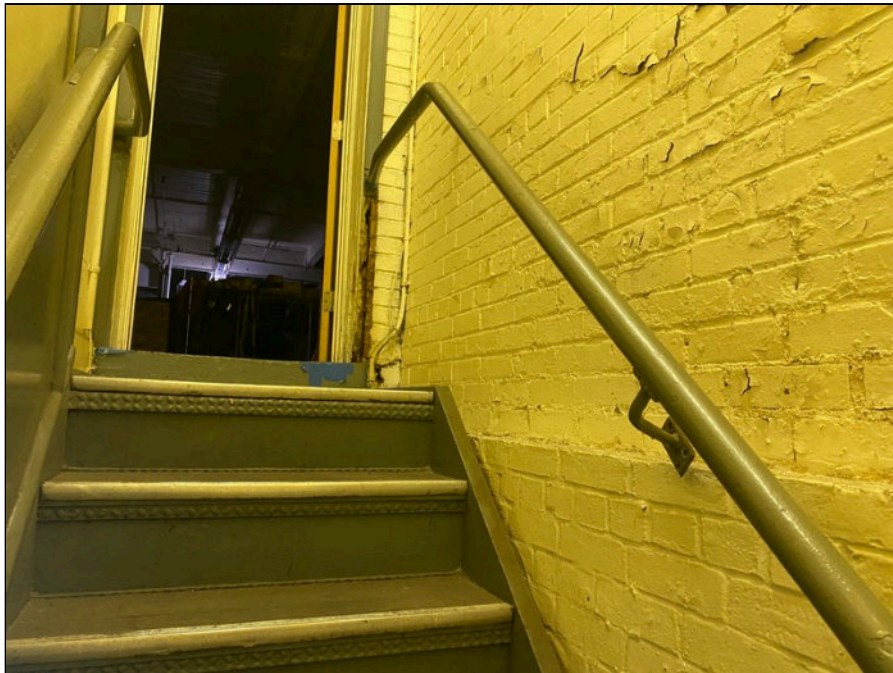
132 - Loose handrail (at right) in stairwell

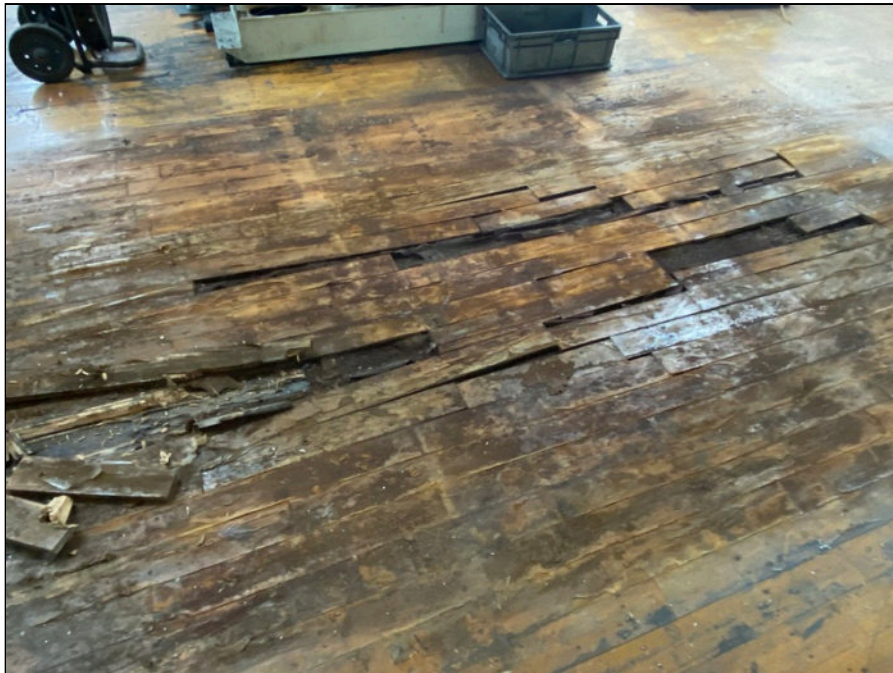
140 - Damaged flooring in plant area

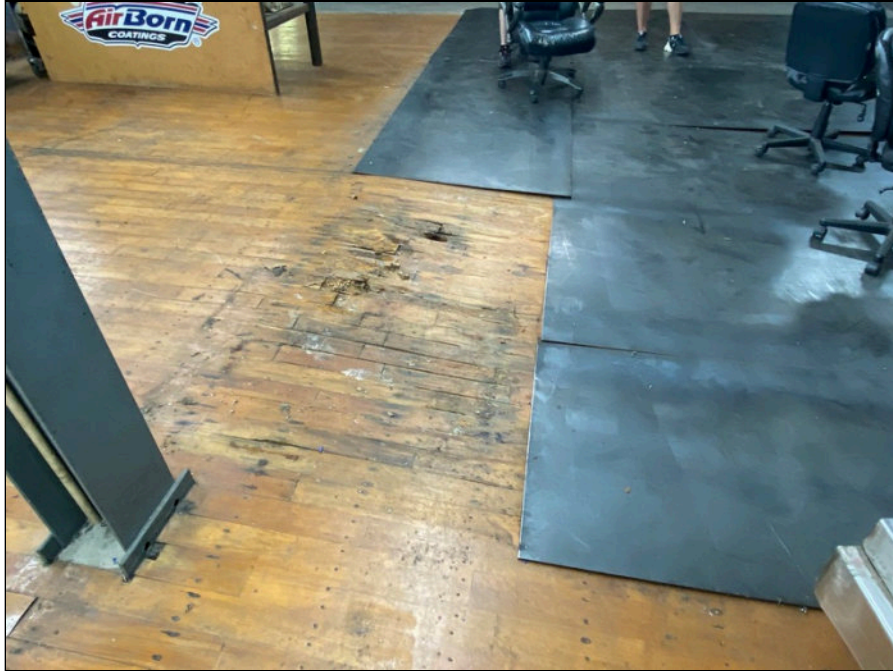
141 - Sagging floor in plant area
