PROPERTY CONDITION ASSESSMENT

108 RUSH STREET
MOUNT HOLLY, NORTH CAROLINA

ECS PROJECT NO. 48:3582

OCTOBER 23, 2023

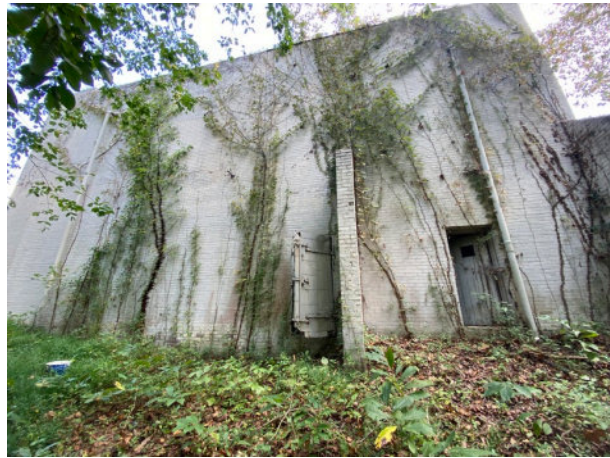
West elevation (note ivy on walls)

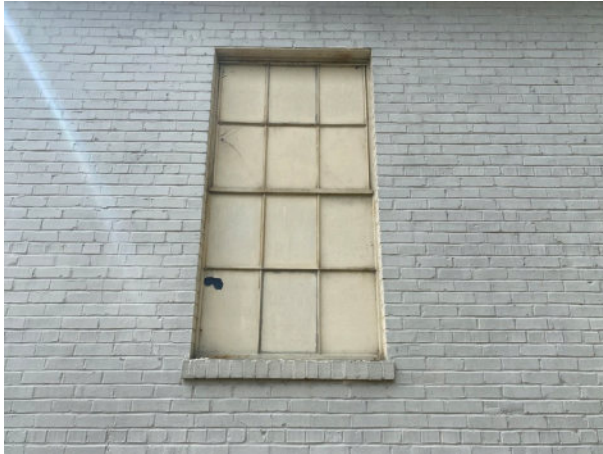
Fenestration for the building consists of single-glazed steel-sash operable window units. The windows appeared to be in generally good/fair condition. Some minor corrosion was noted on the window framing, and some broken glass was observed. We recommend the framing be cleaned and repainted and the broken glass replaced. this can be doen as part of general maintenance.

Typical steel window (exterior view)

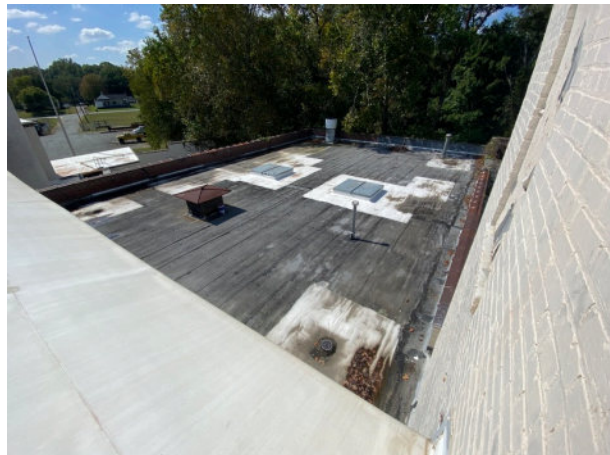
Modified bitumen roof at west wing

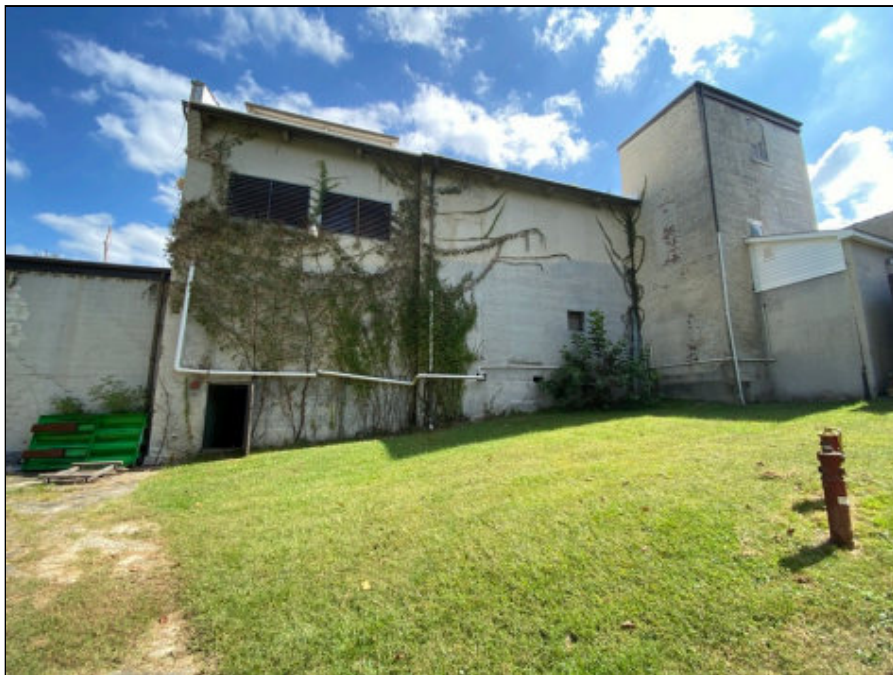
10 - West elevation (note ivy on walls)

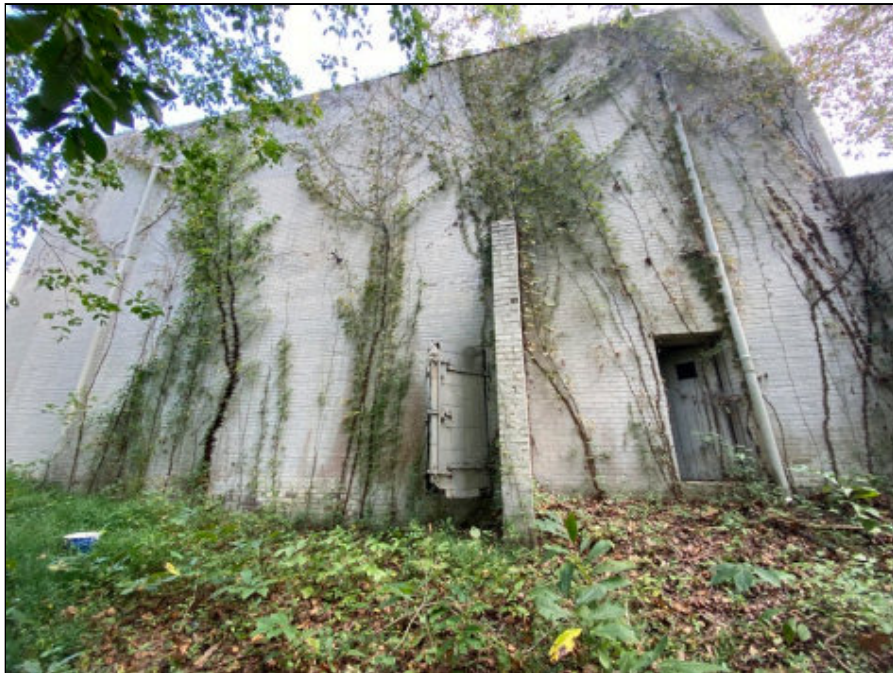
12 - West elevation (note ivy on walls)

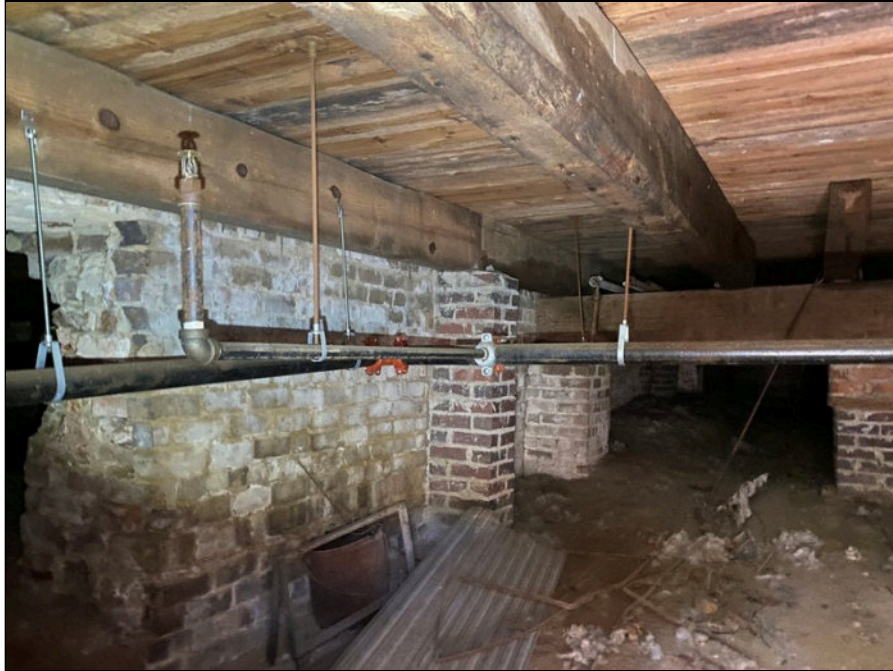
39 - Crawlspace below floor

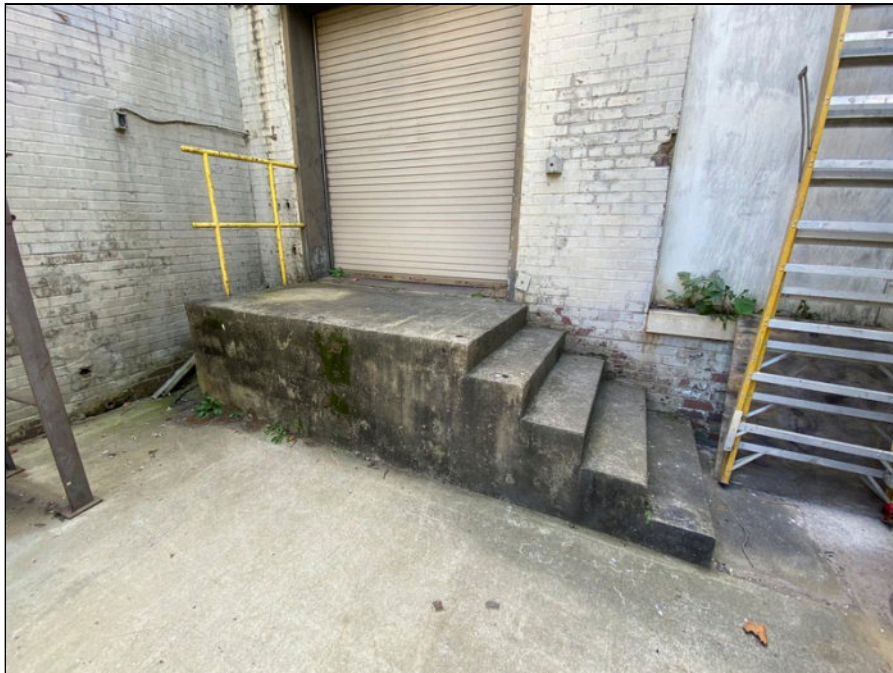
46 - Typical concrete steps at doorway

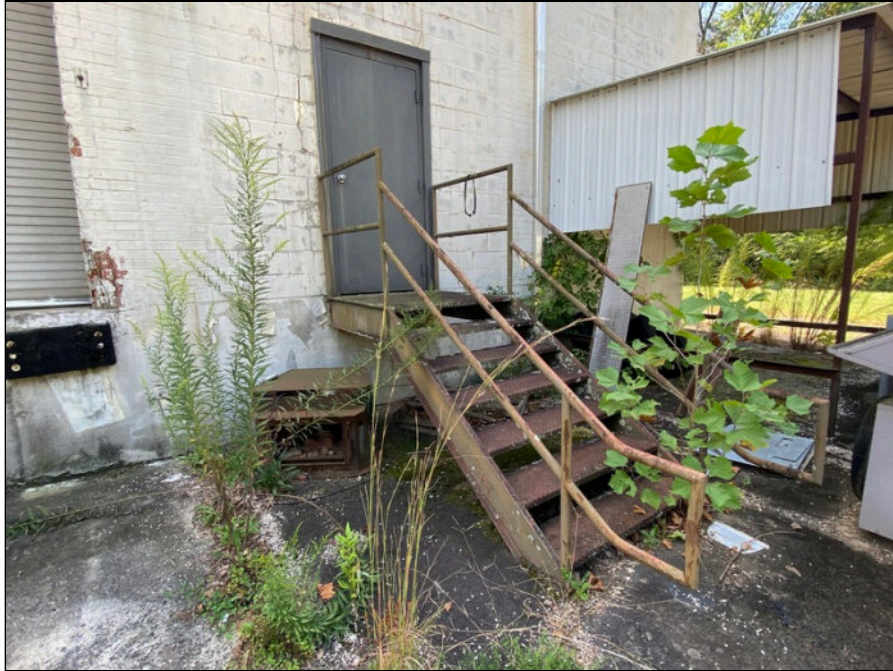
47 - Metal steps at doorway

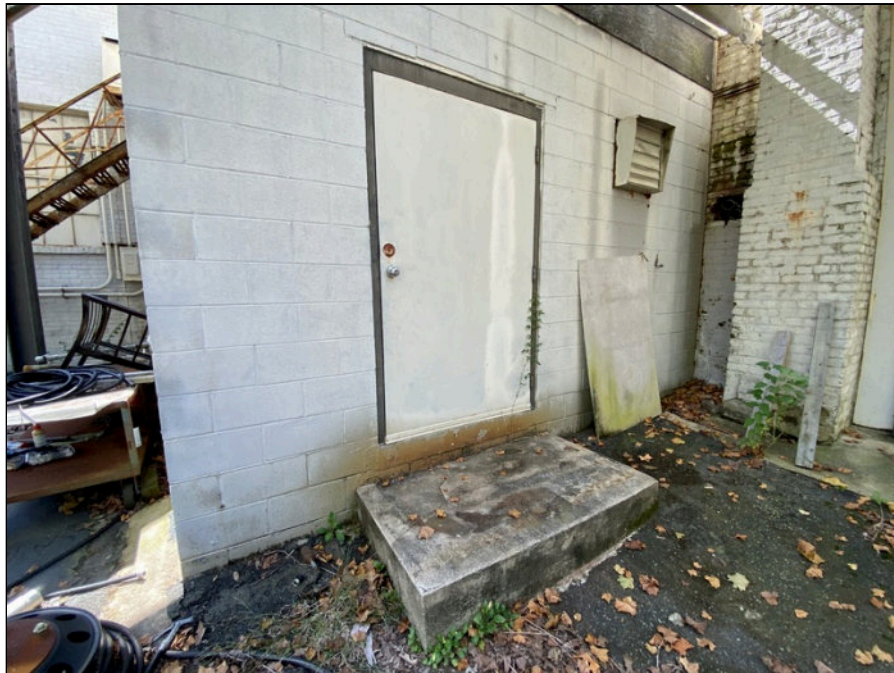
54 - Typical personnel door

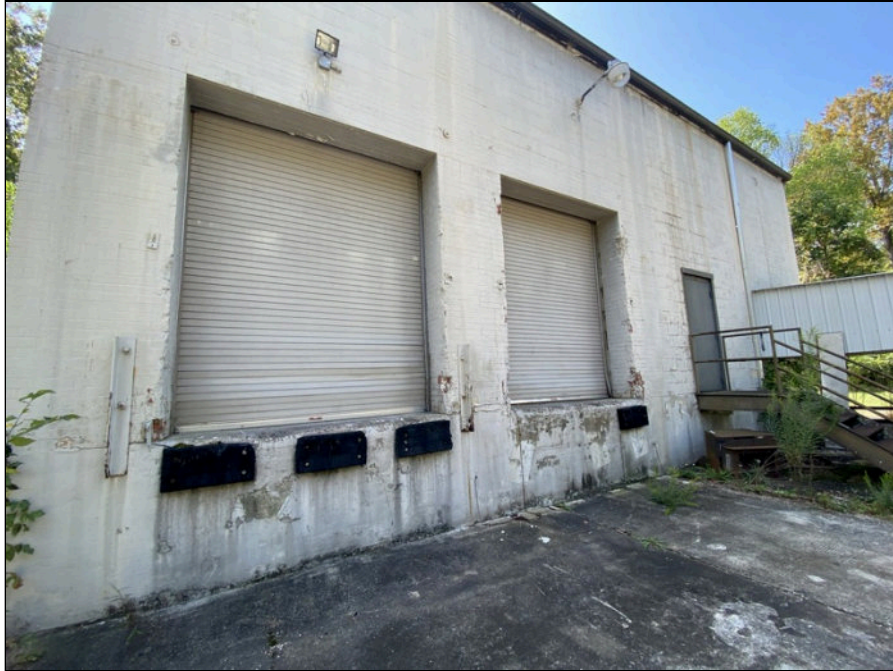
55 - Typical overhead doors

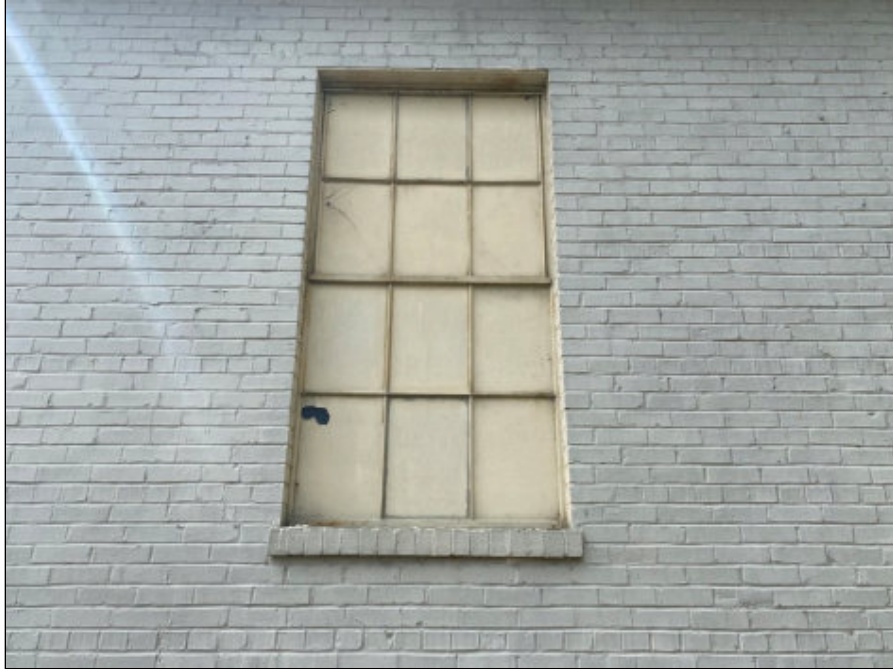
57 - Typical steel window (exterior view)

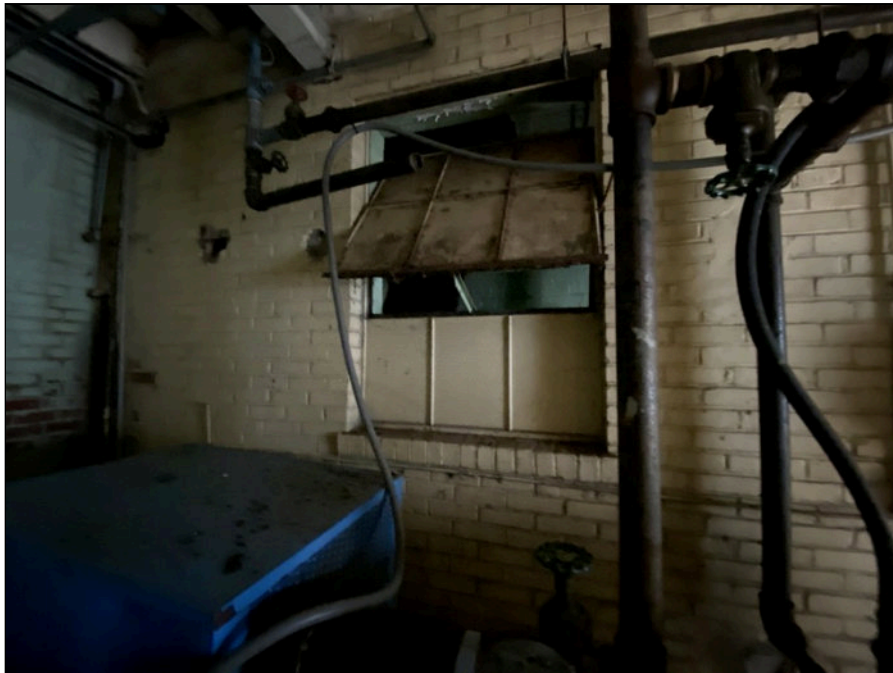
58 - Typical steel window (interior view)

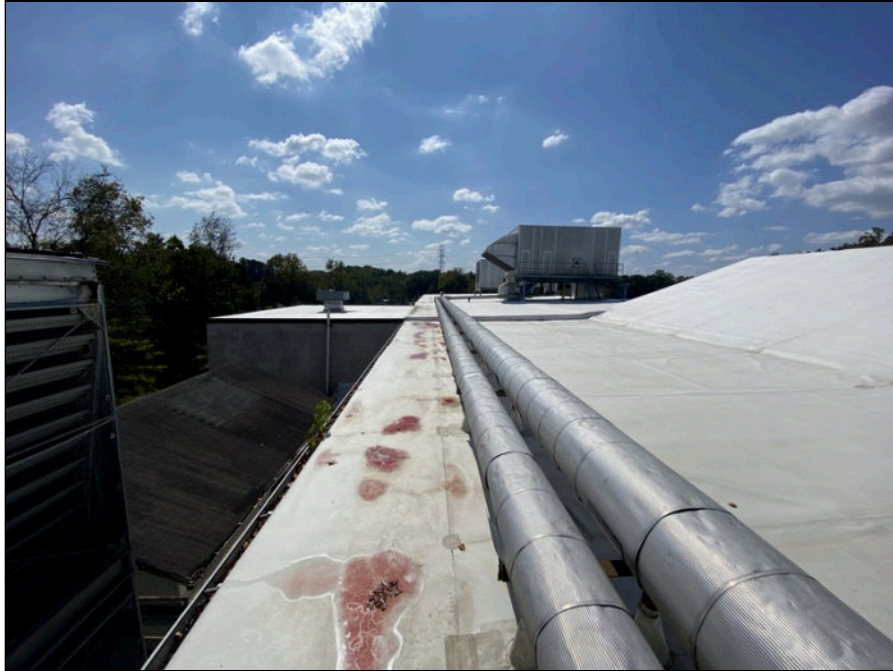
59 - View of roof

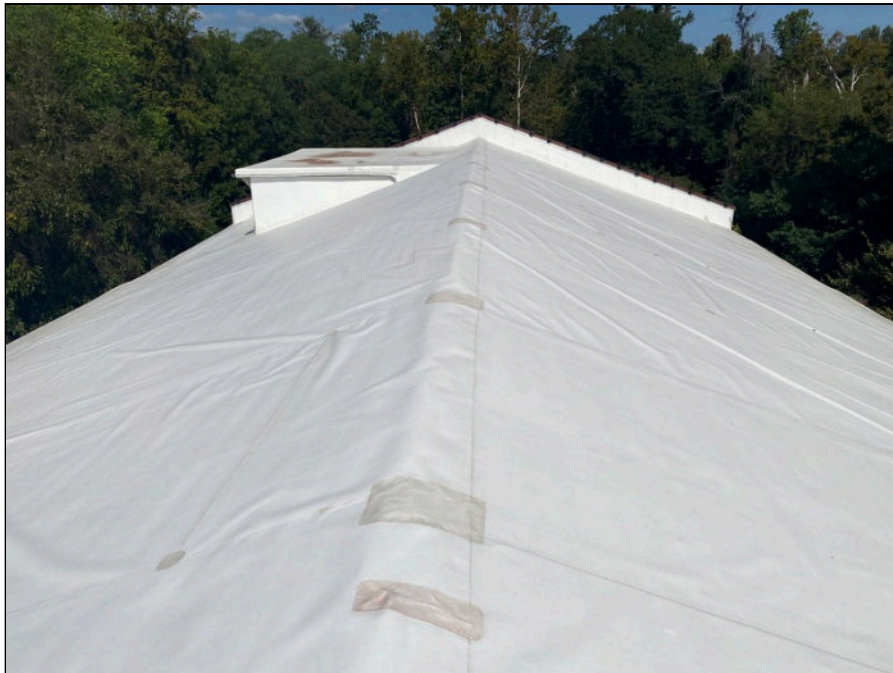
60 - View of roof

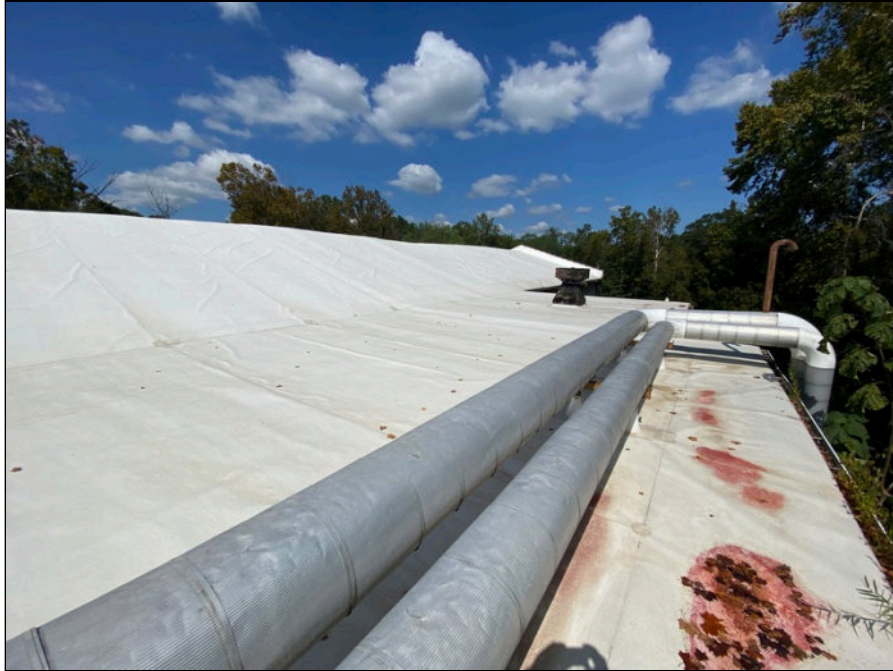
61 - View of roof

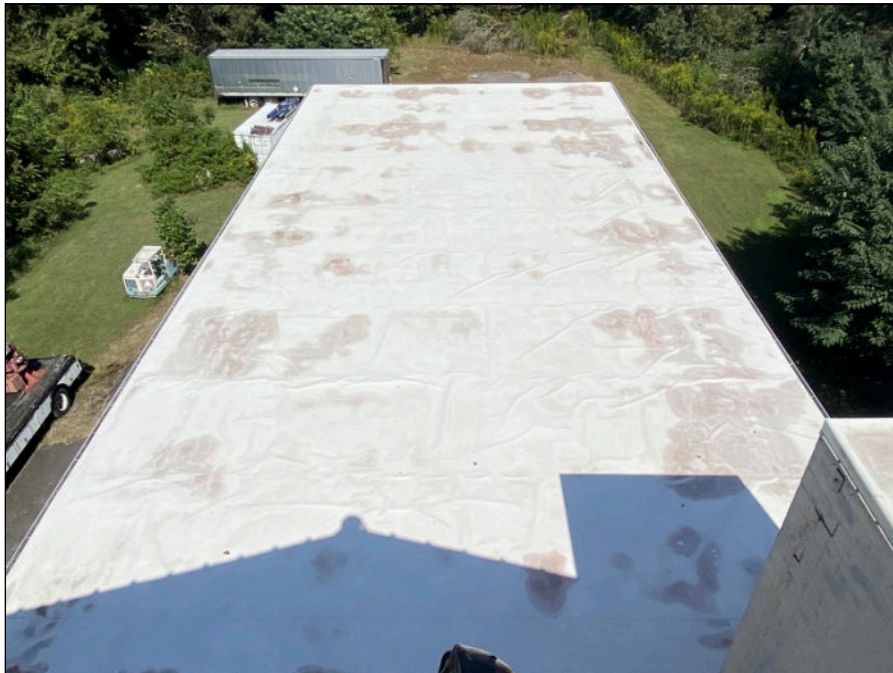
62 - View of roof at north end

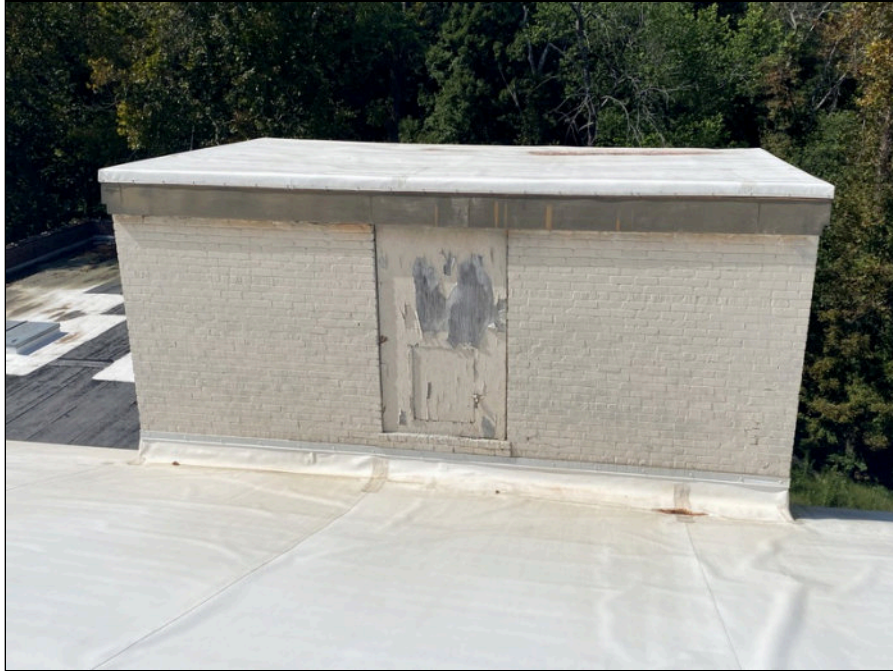
63 - Abandoned elevator penthouse

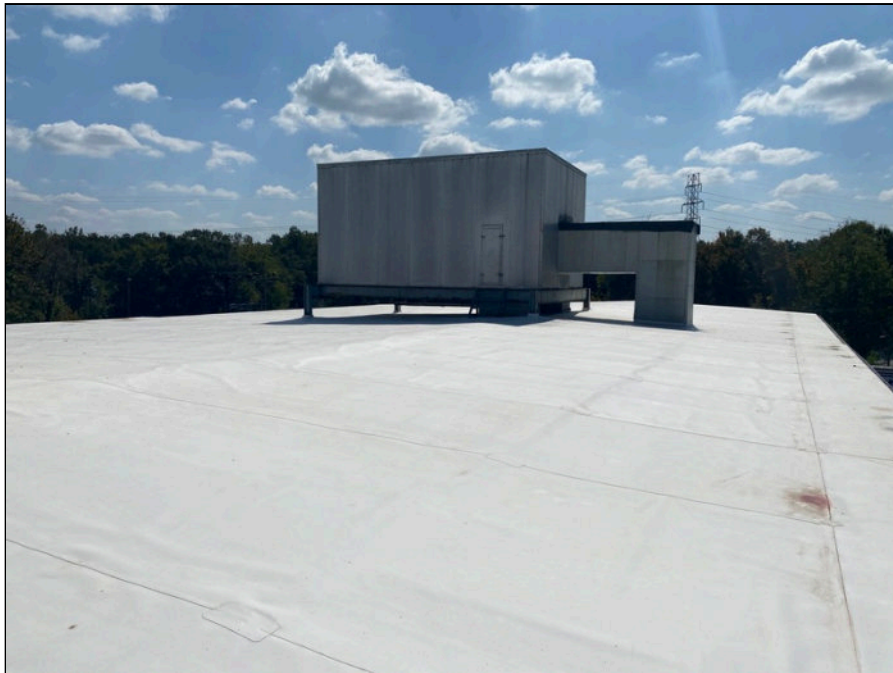
64 - View of roof

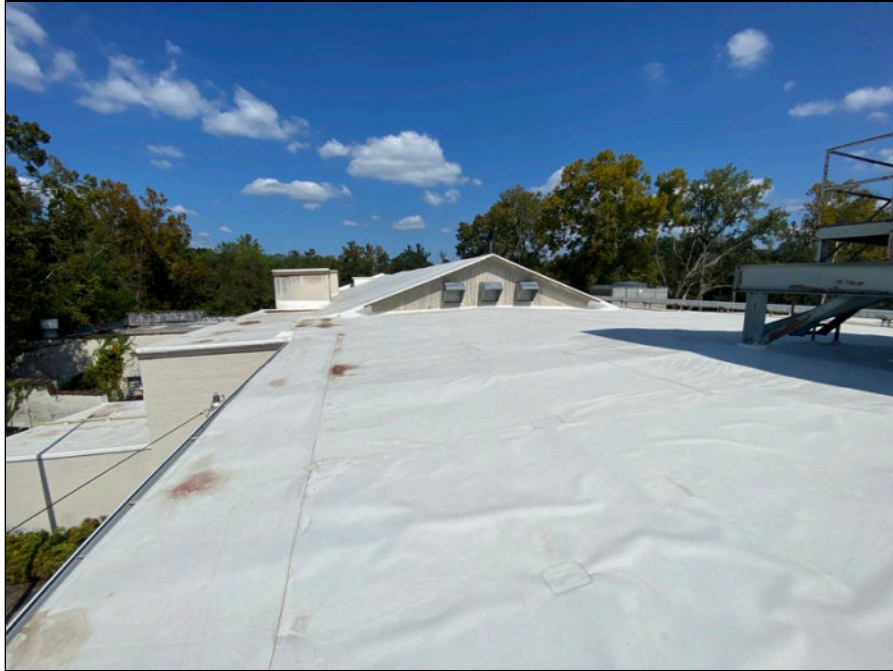
65 - View of roof

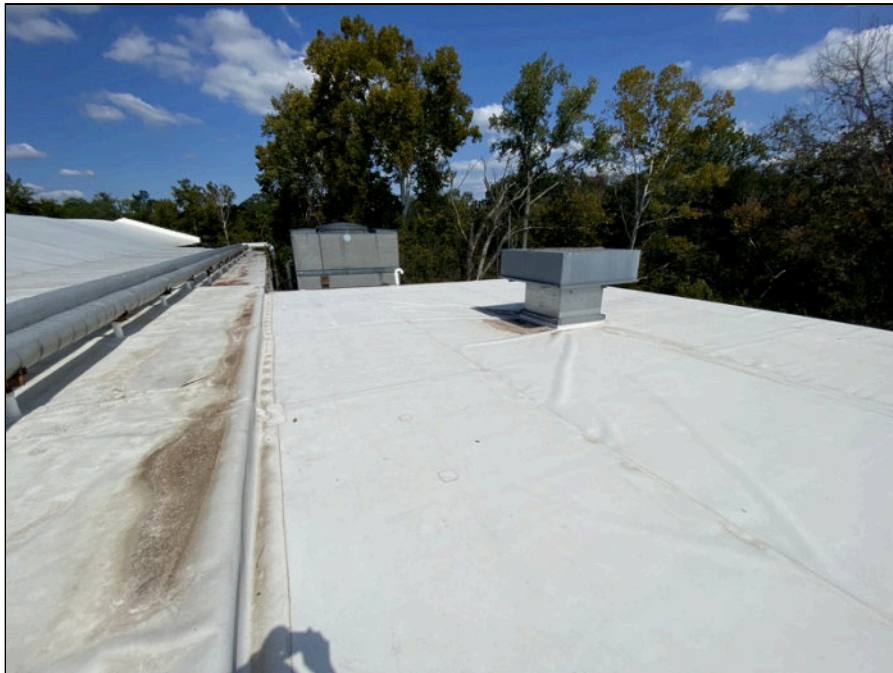
66 - View of roof

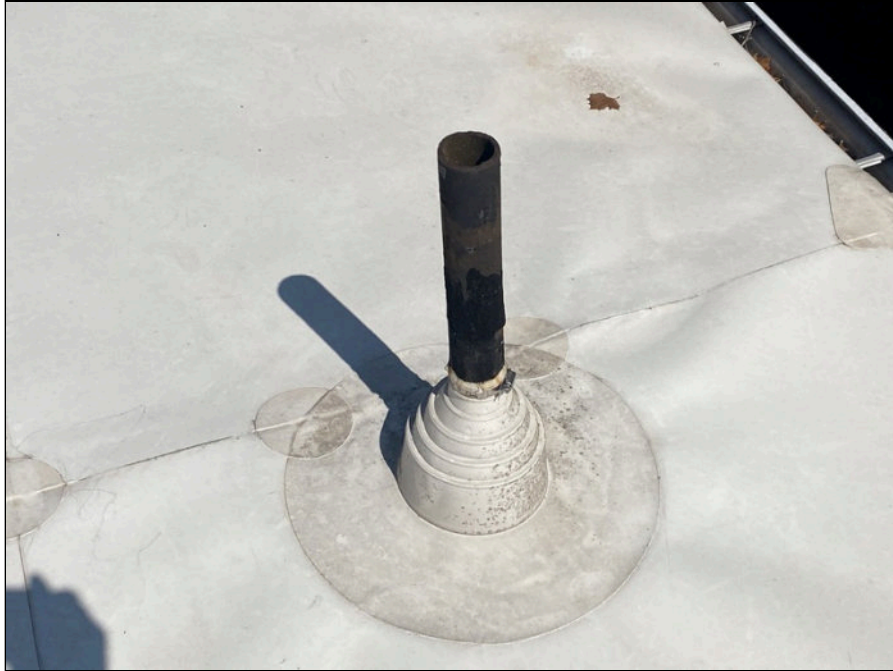
67 - Typical vent pipe

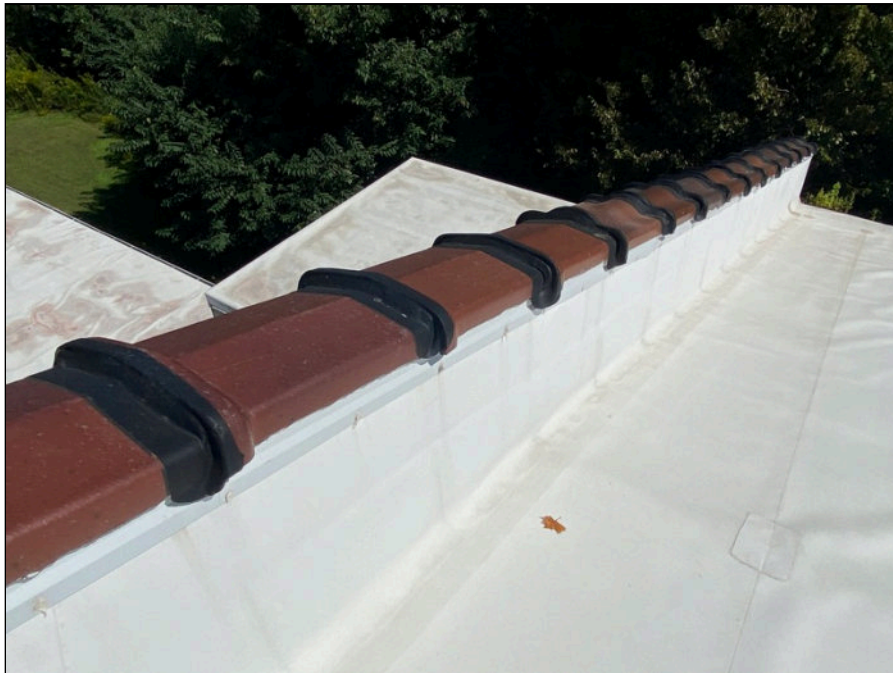
68 - Terra cotta coping at parapet

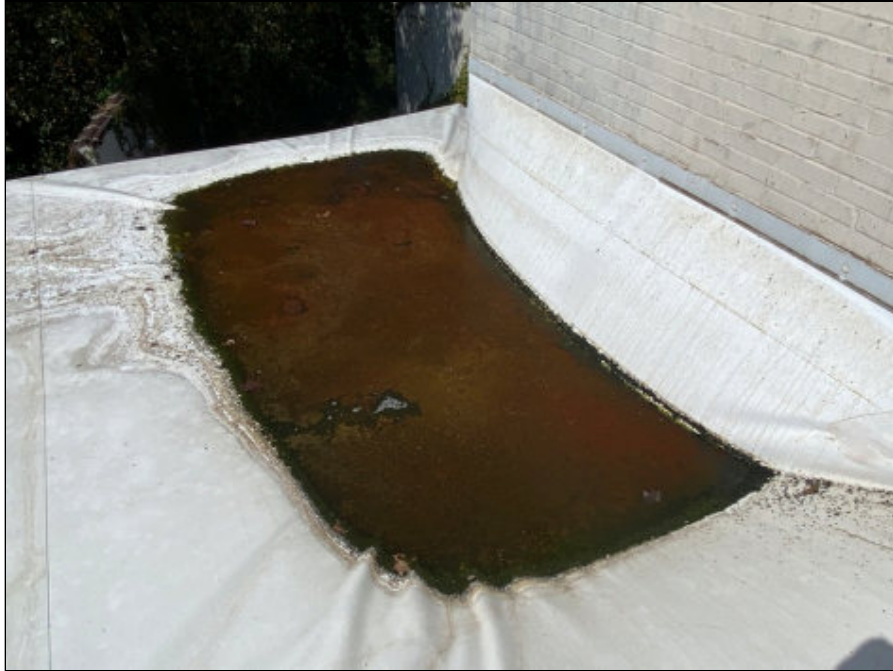
69 - Ponding near elevator penthouse

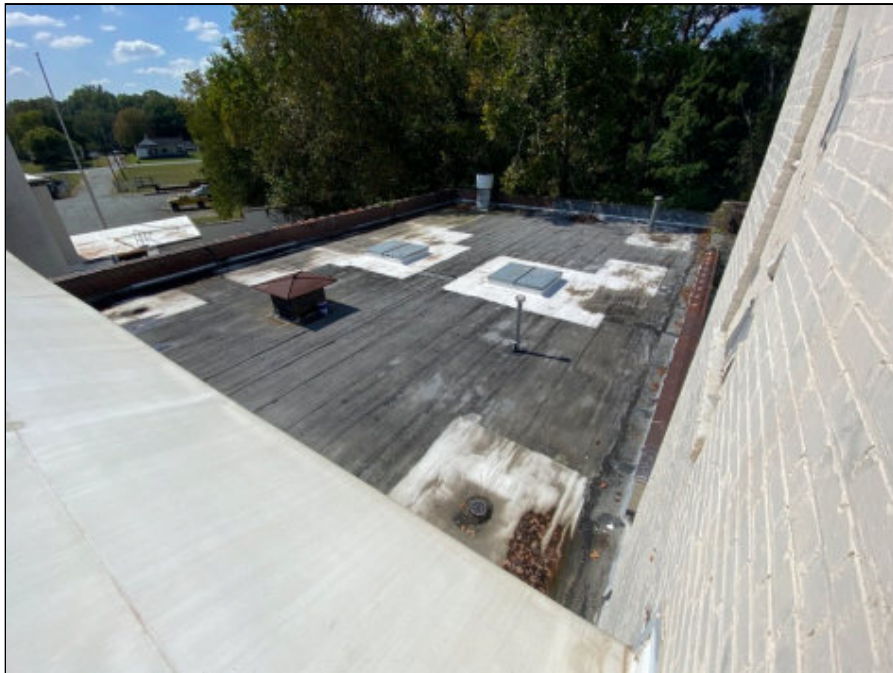
70 - Modified bitumen roof at west wing

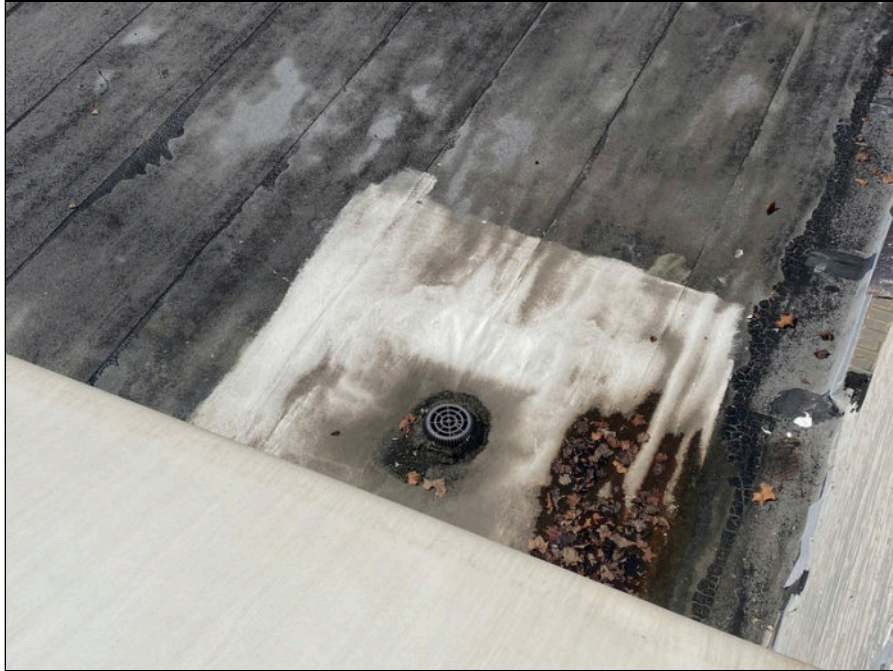
71 - Typical roof drain at west wing

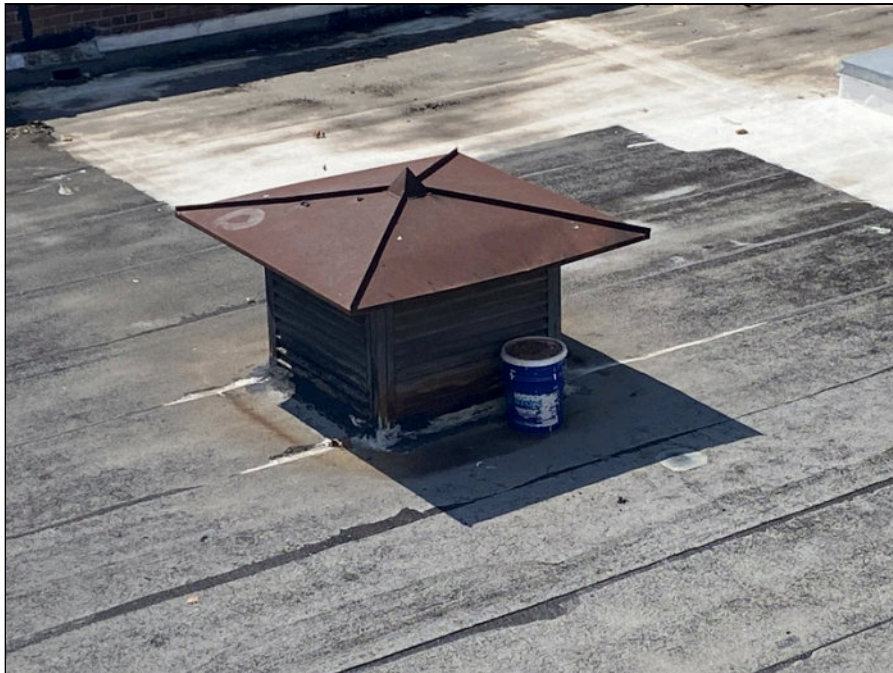
72 - Exhaust vent at west wing

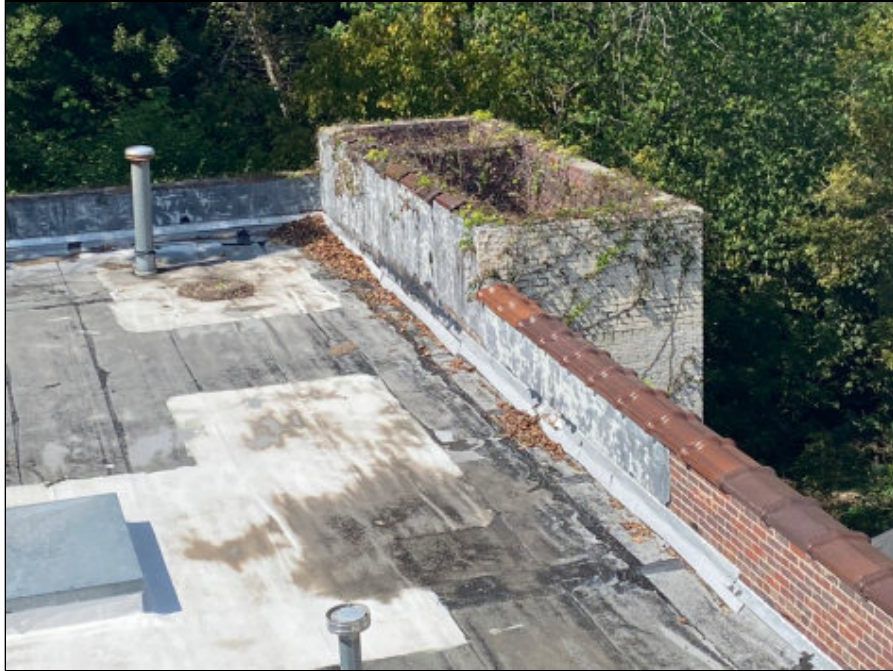
73 - Parapet at west wing

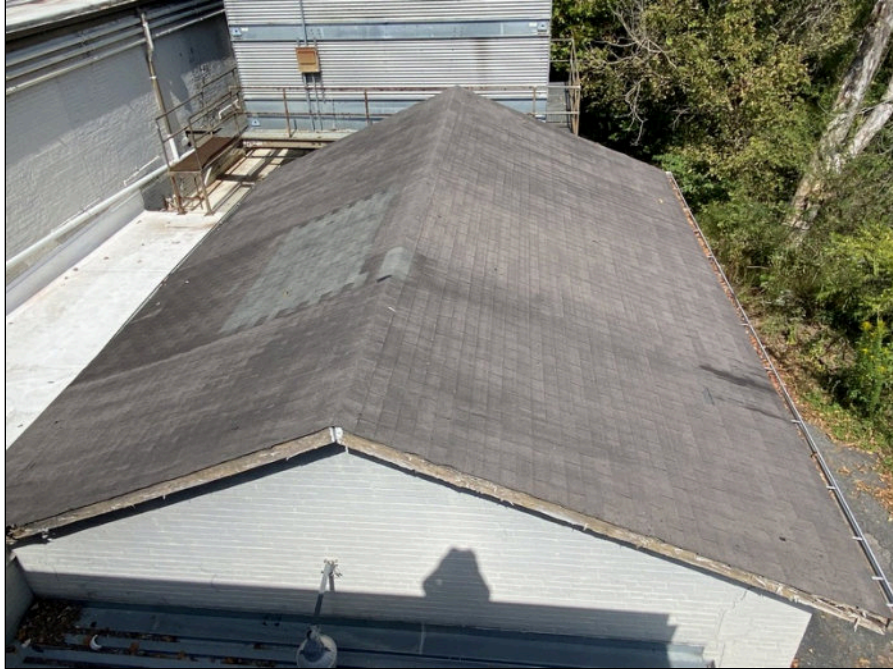
75 - Asphalt shingles at east side

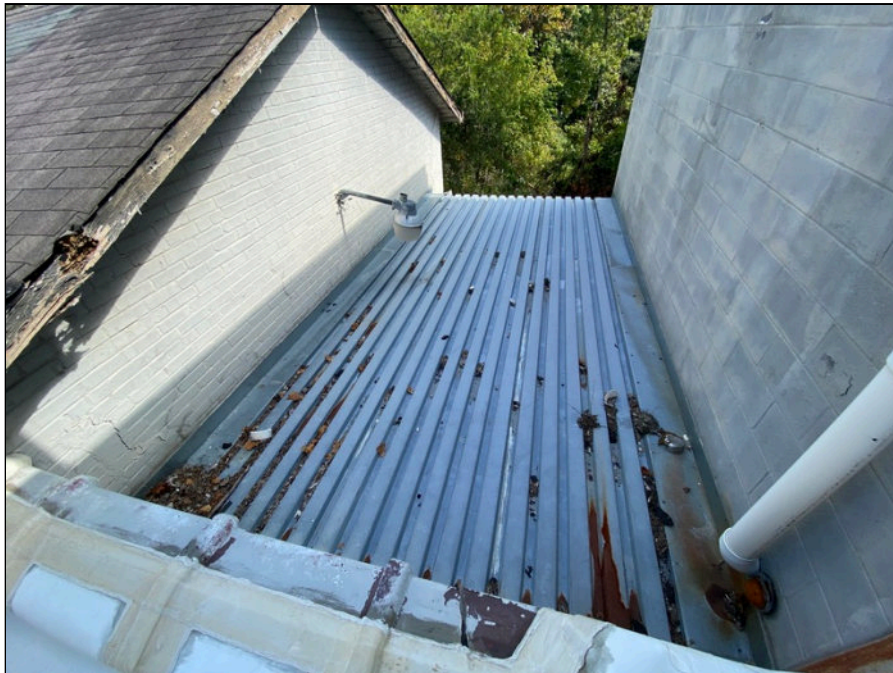
76 - Metal roofing at east side

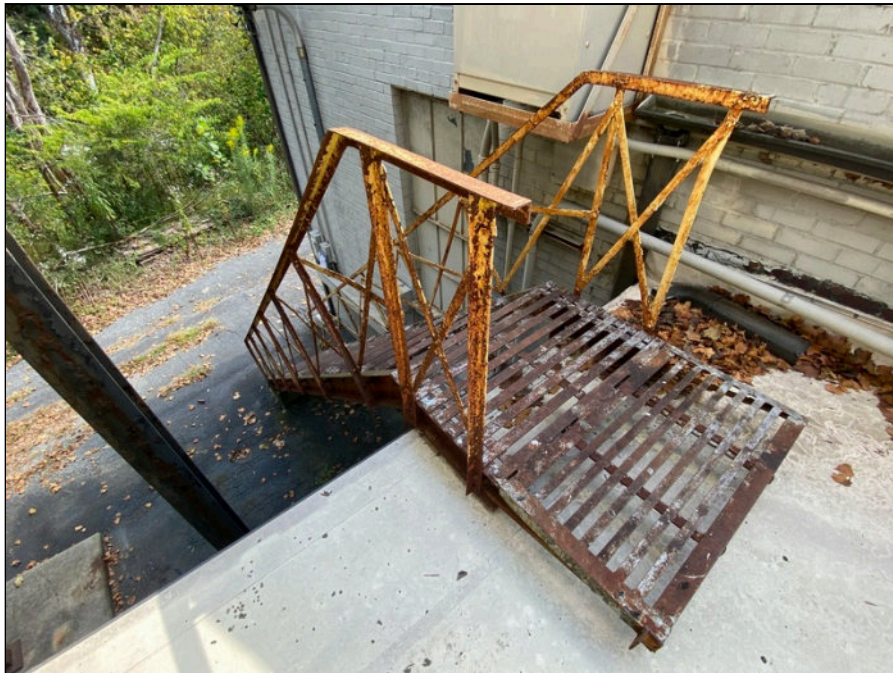
80 - View of lower roof ladder

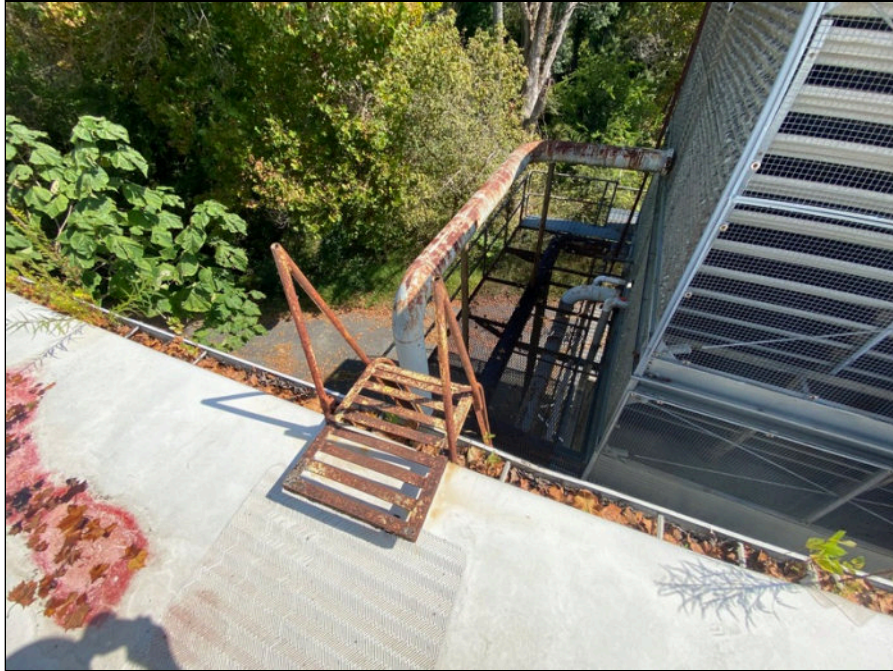
81 - View of upper roof ladder

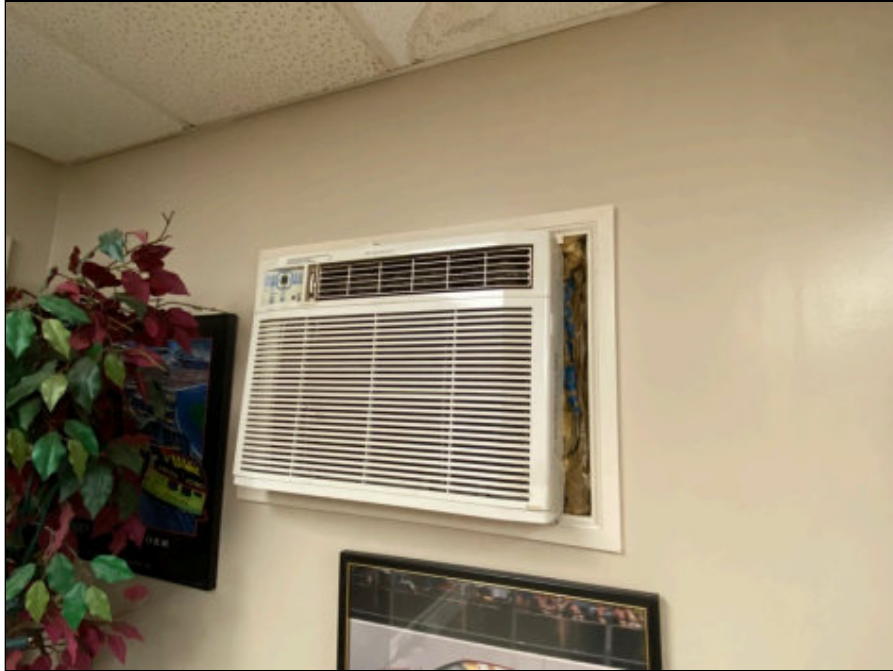
85 - Typical window air conditioner

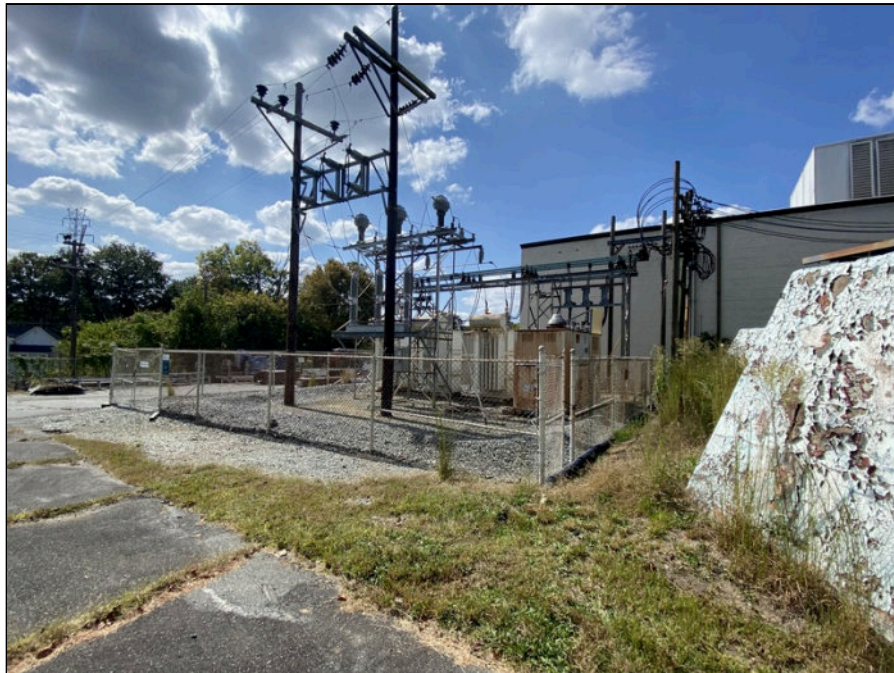
90 - View of electrical substation at east side

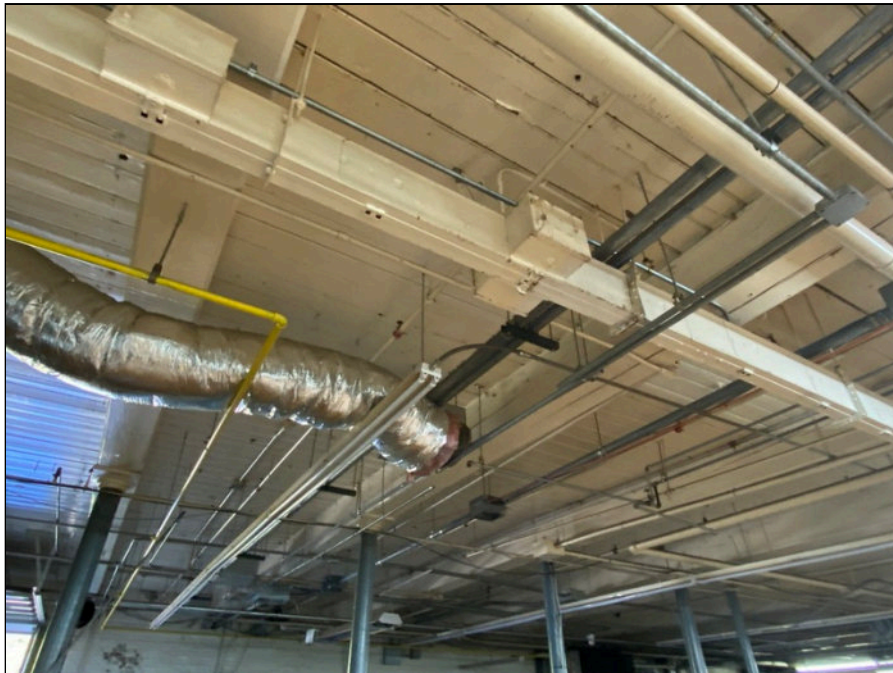
92 - Electrical bus duct (at center)

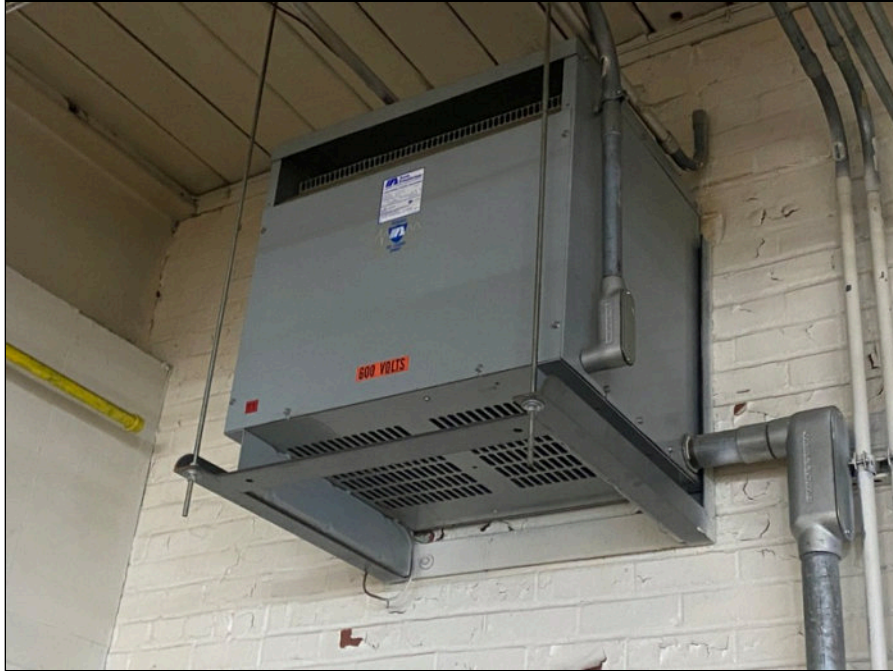
93 - Typical step-down transformer

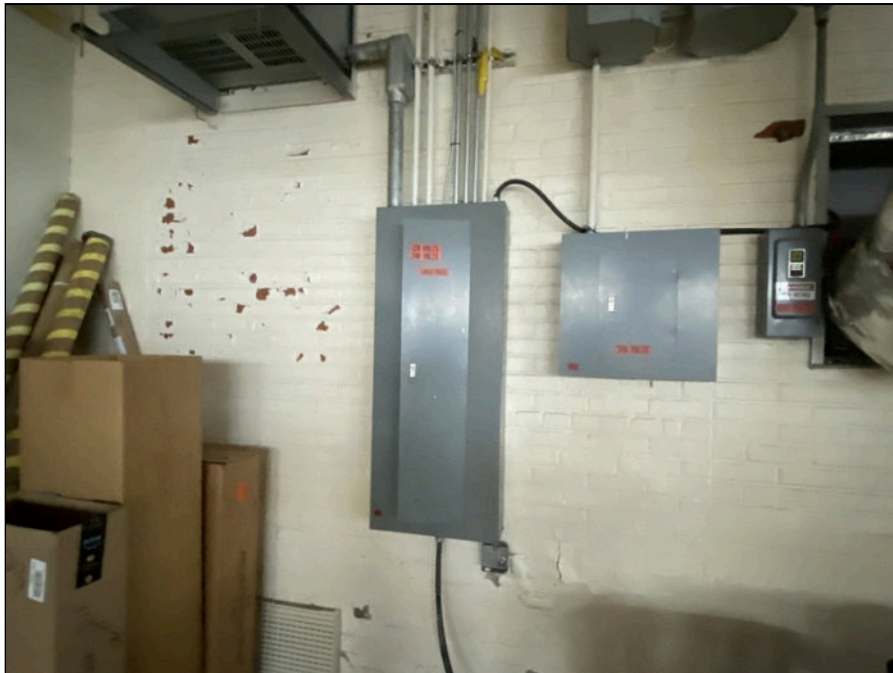
94 - Typical electrical panel

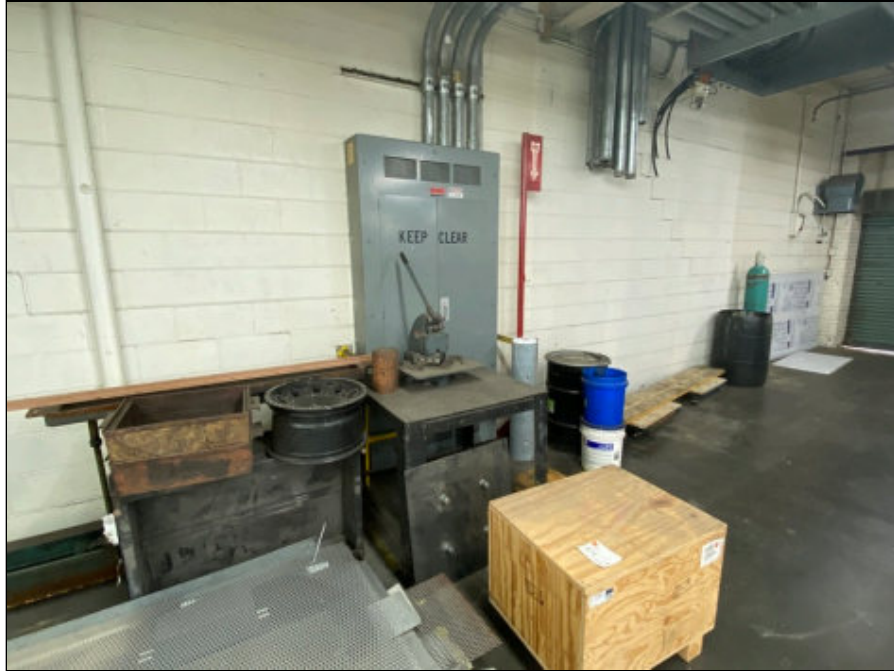
95 - Blocked electrical panel

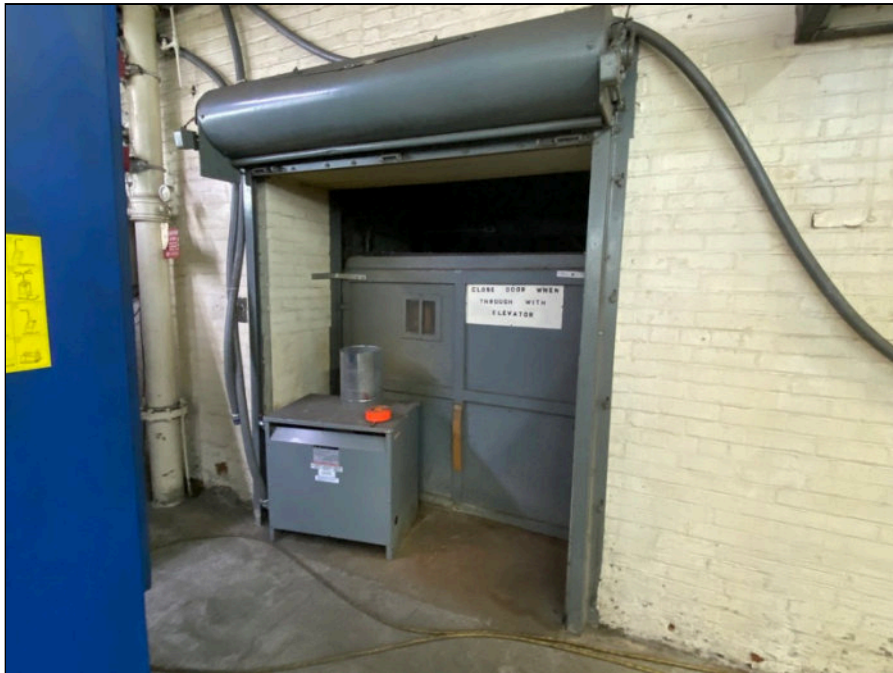
100 - Abandoned freight elevator

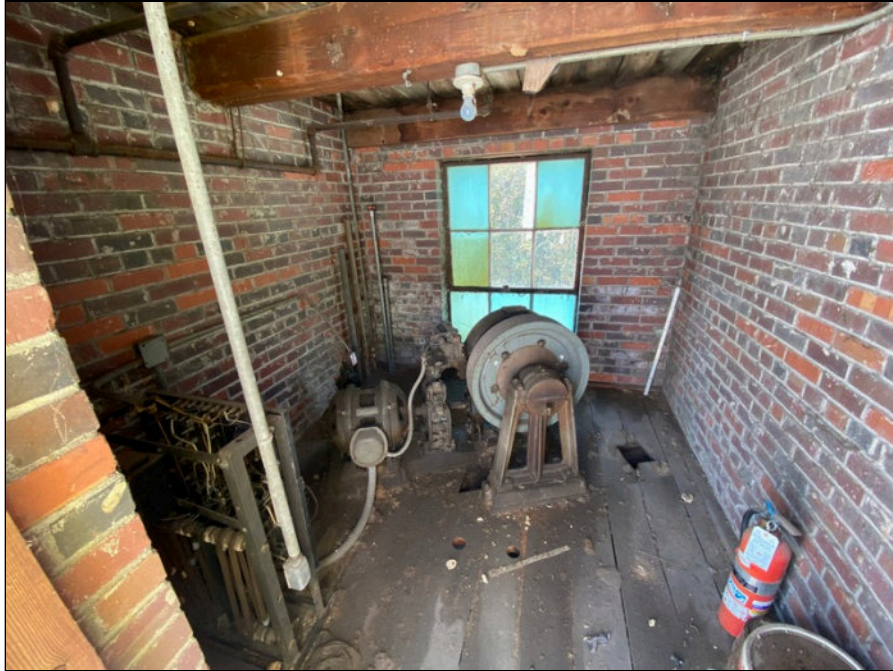
101 - Abandoned freight elevator penthouse
