PROPERTY CONDITION ASSESSMENT

108 RUSH STREET
MOUNT HOLLY, NORTH CAROLINA

ECS PROJECT NO. 48:3582

OCTOBER 23, 2023

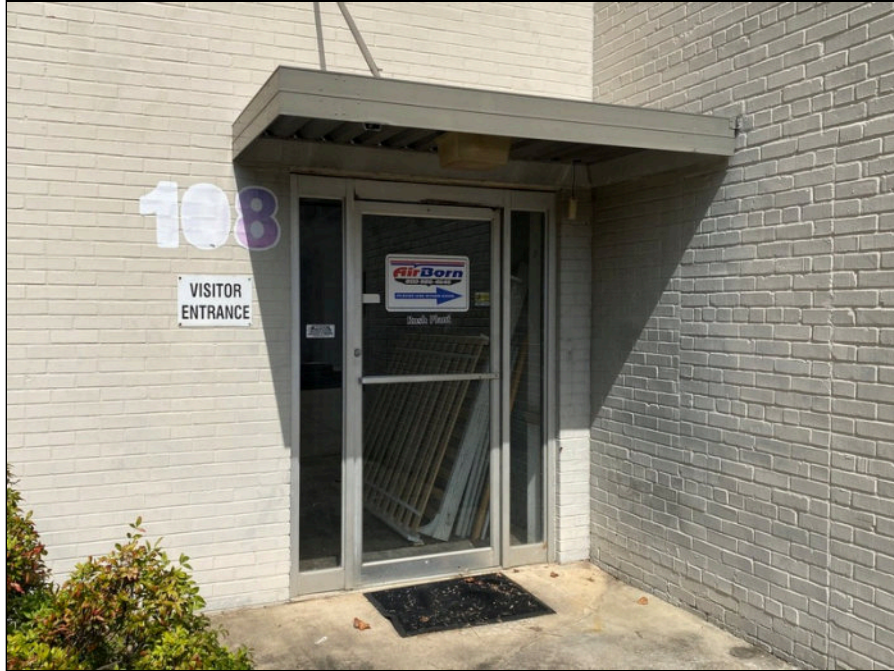
53 - Main entrance door

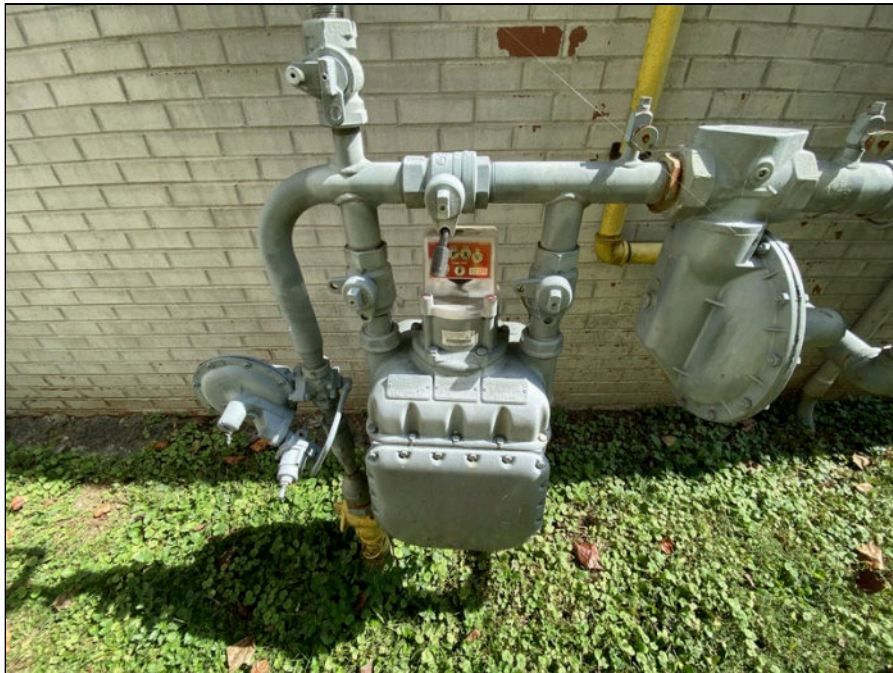
82 - Gas meter

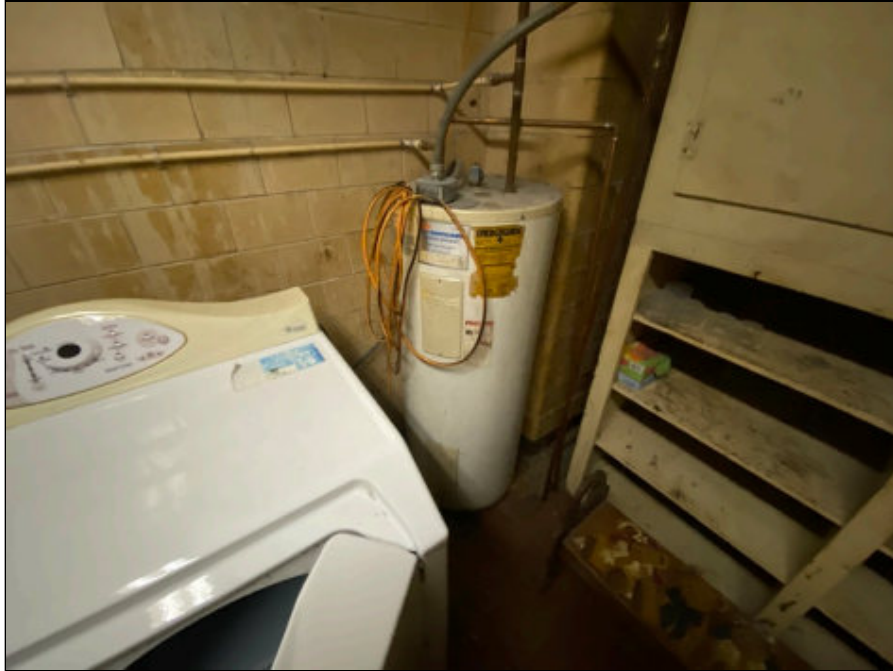
83 - Water heater

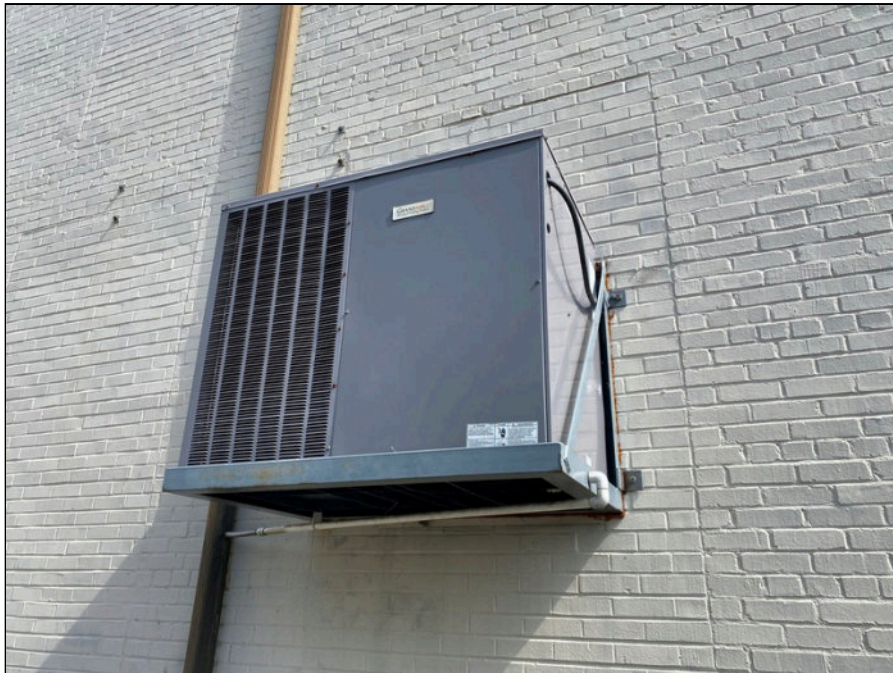
84 - Typical package unit

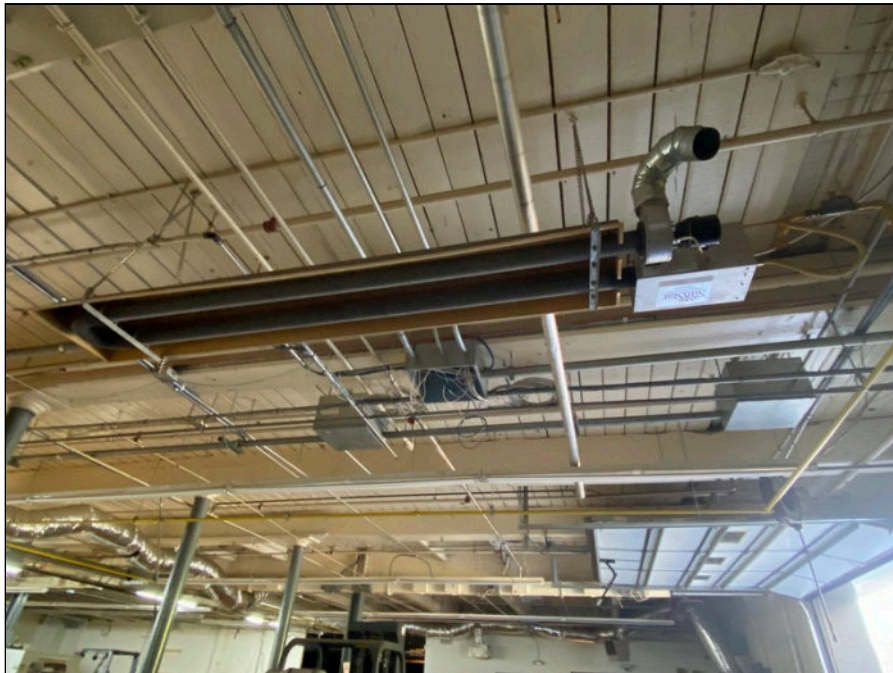
86 - Gas-fired unit heater

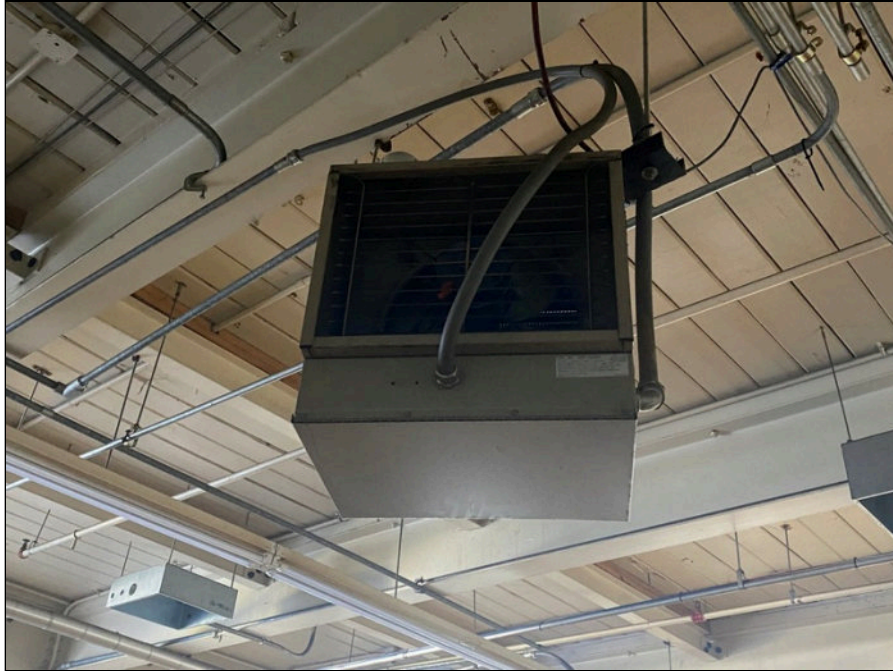
87 - Typical electric unit heater

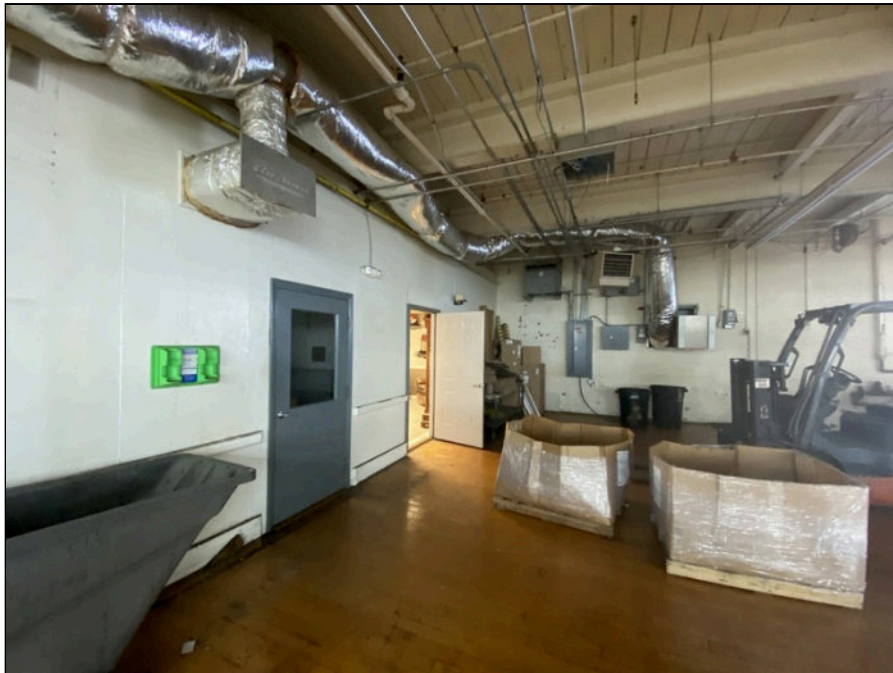
88 - Typical ductwork

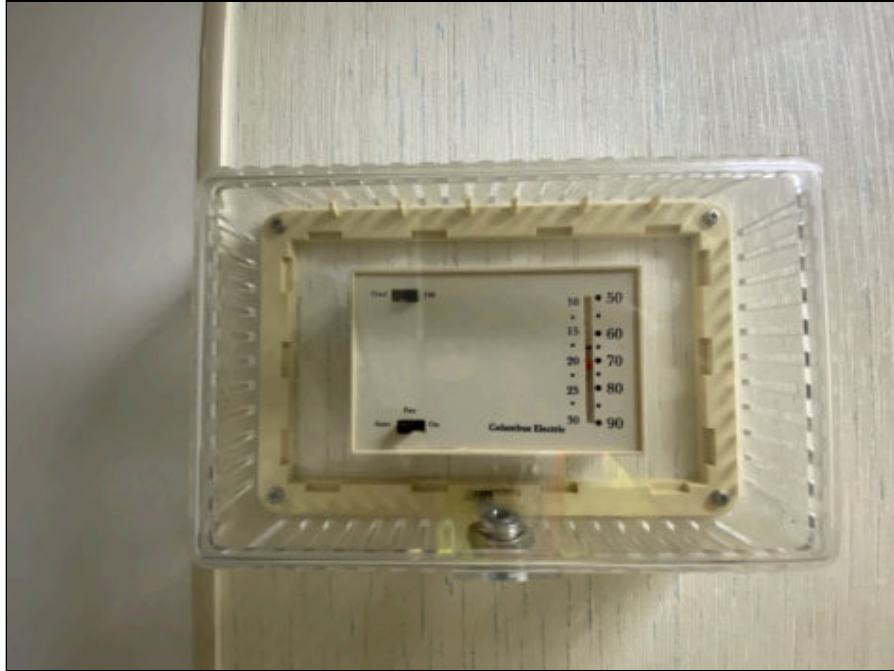
89 - Typical thermostat

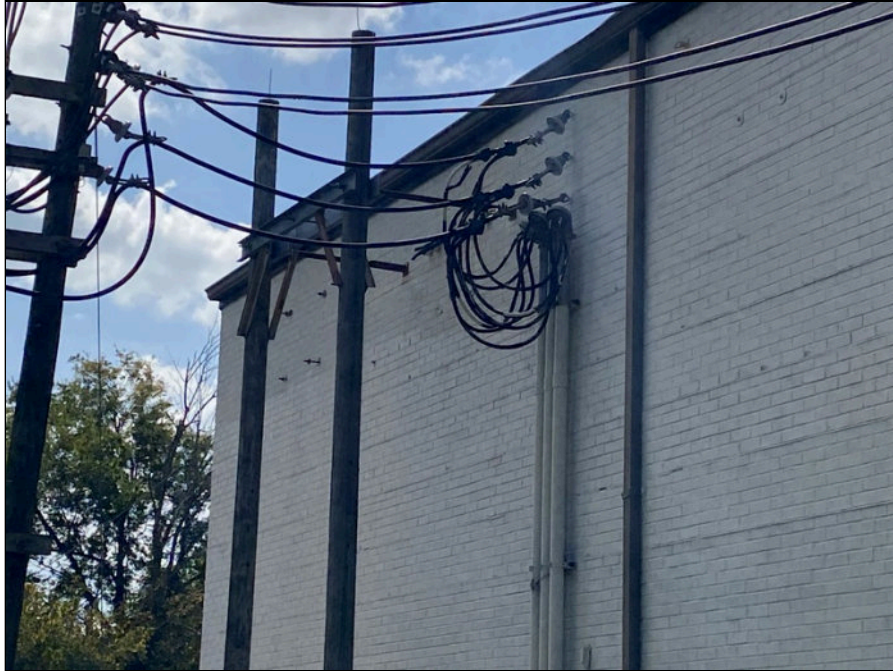
91 - Electrical entrance
